## EXTERNAL FAÇADE CONDITION SURVEY

**THE PRIORY  
GRENOBLE ROAD, OXFORD**

**FIROKA (OXFORD LEISURE)  
LTD**

Job No 04315

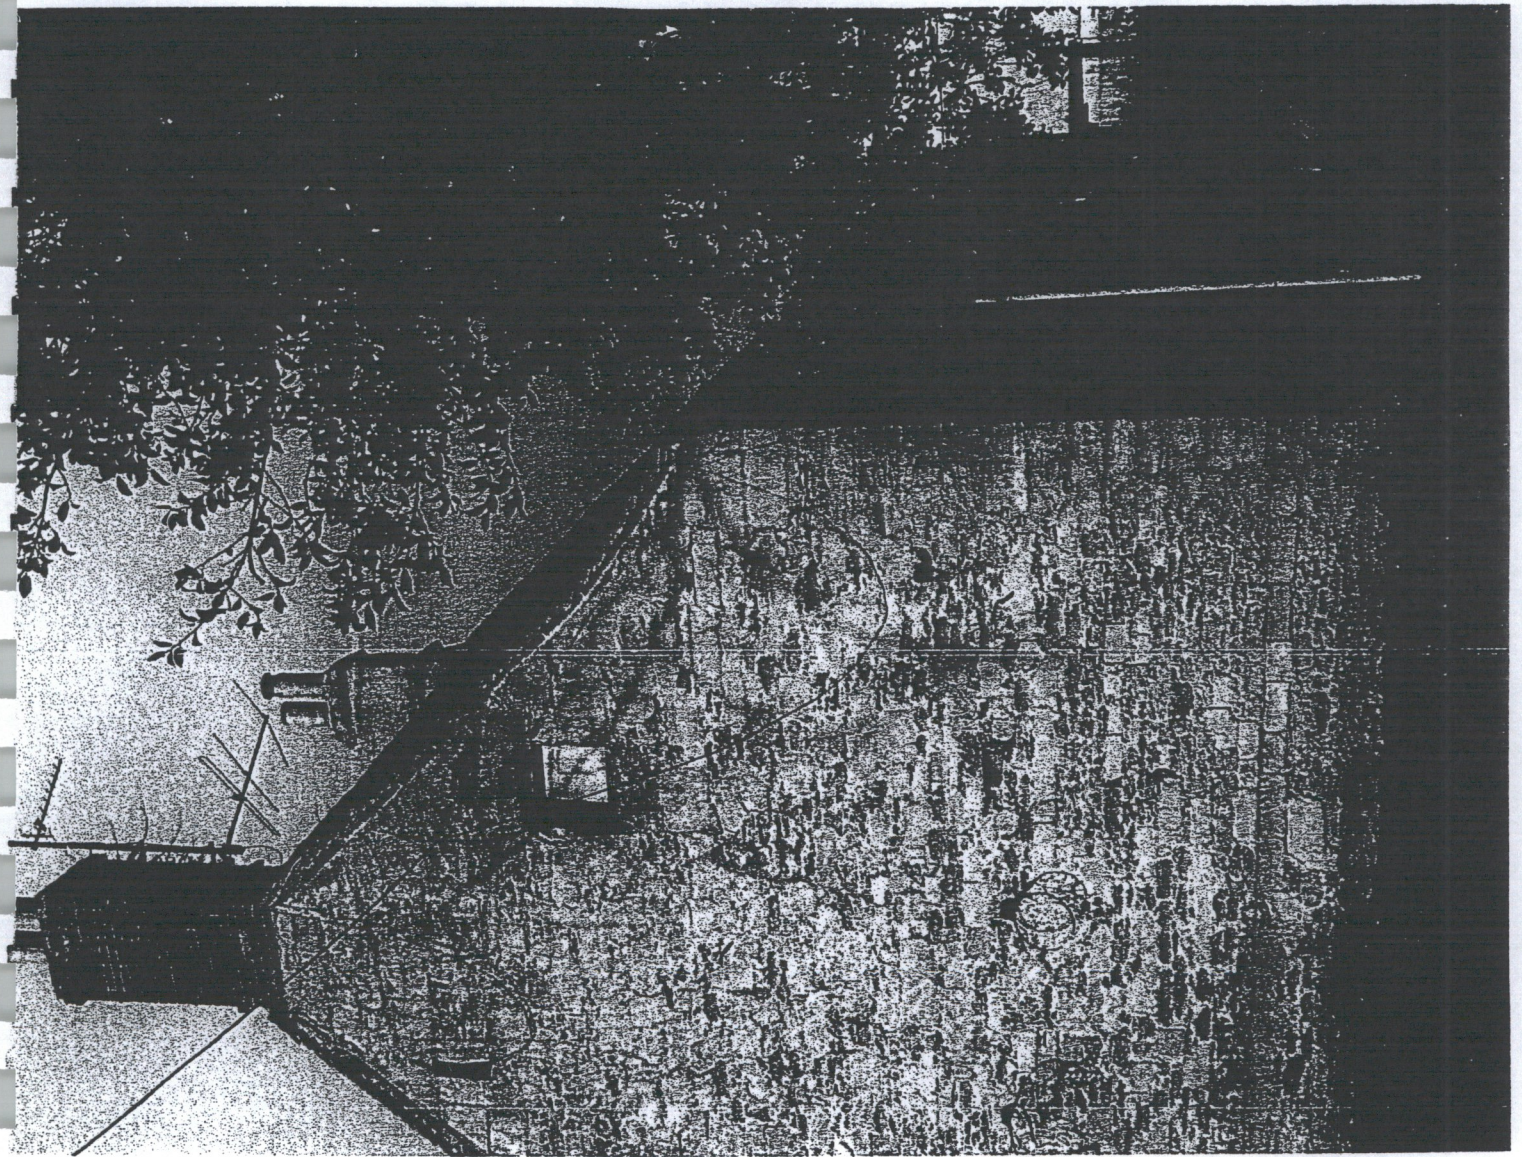
PHOTO No 1.

The external walls are of random stone rubble with ashlar stone quoins. Some areas indicate signs of minor structural movement, however, this is historical and has been previously filled with cement mortar (eg see photo nos 1-3, Appendix A). No new areas of movement were visible. Additional surface repairs have been carried out, presumably where stones were either missing or damaged, which have also been undertaken in a hard cement mortar. This can and is causing additional spalling and damage to adjacent soft stone which in many areas is now loose or missing.

SOUTH EAST CORNER

- It is recommended that all areas where cement/sand mortar has been used for repair, re-facing and re-pointing are carefully raked out and replaced with a Type C Hydraulic Mortar (NHL5:Sand, 1:2 mix).

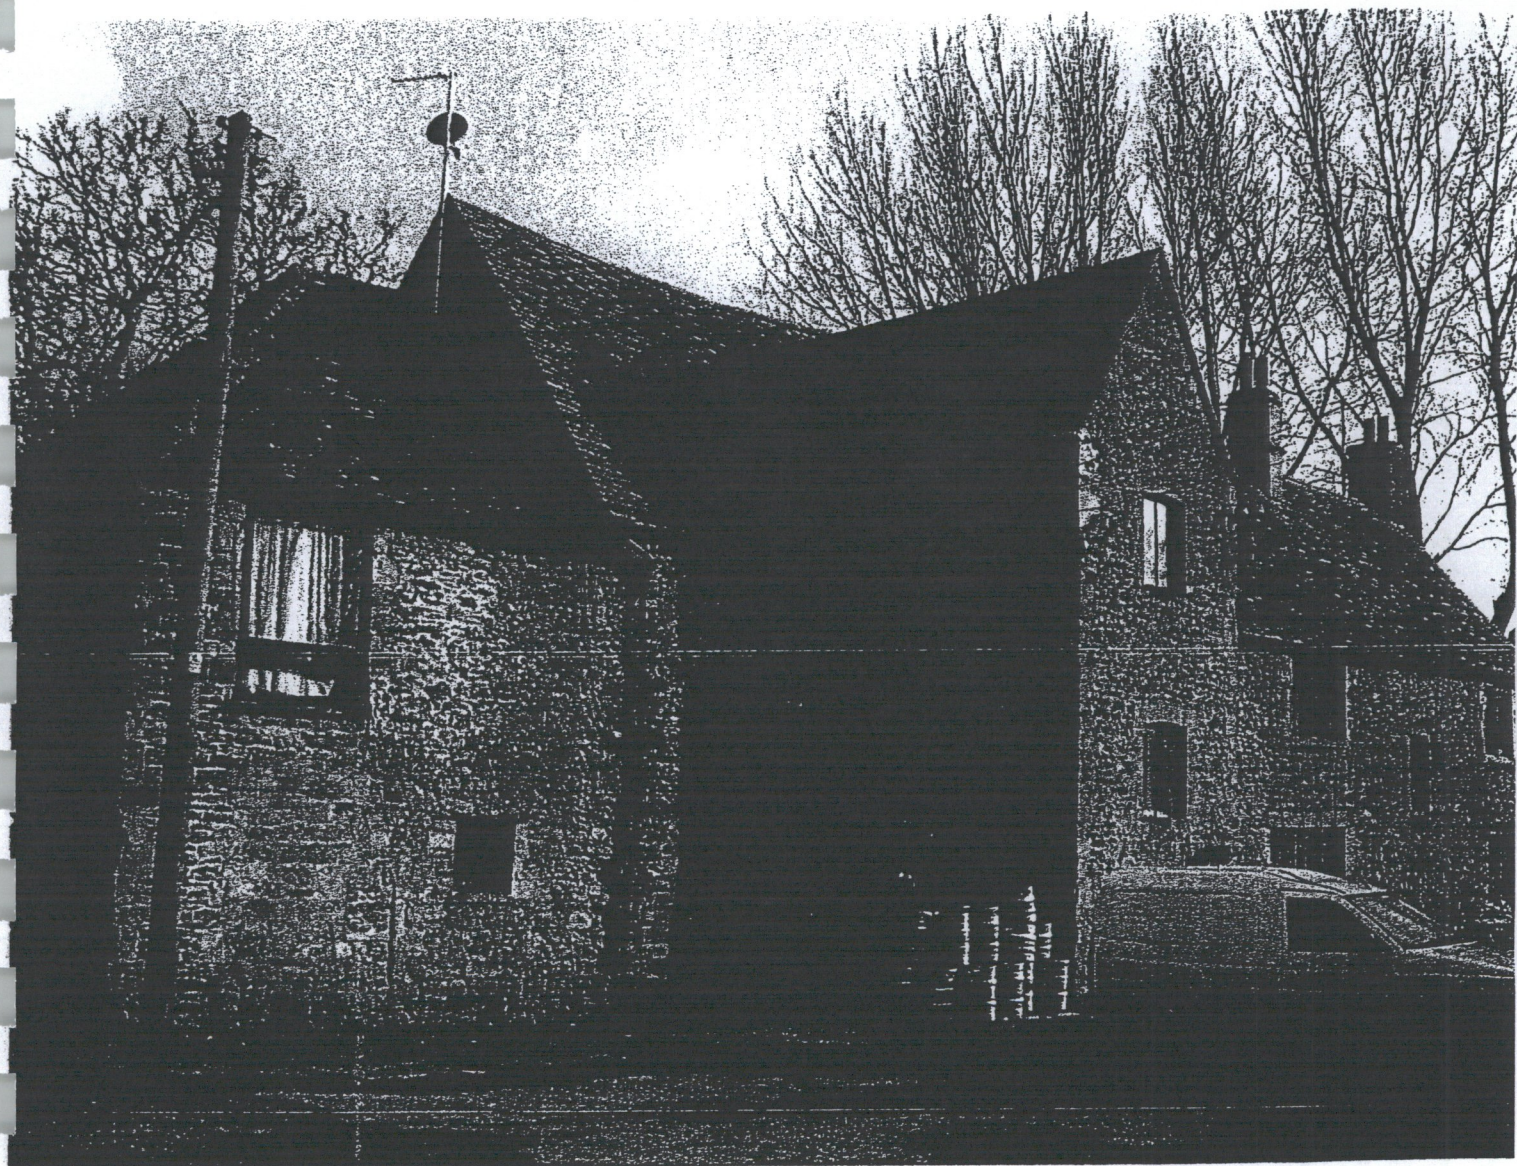
WEST ELEVATION

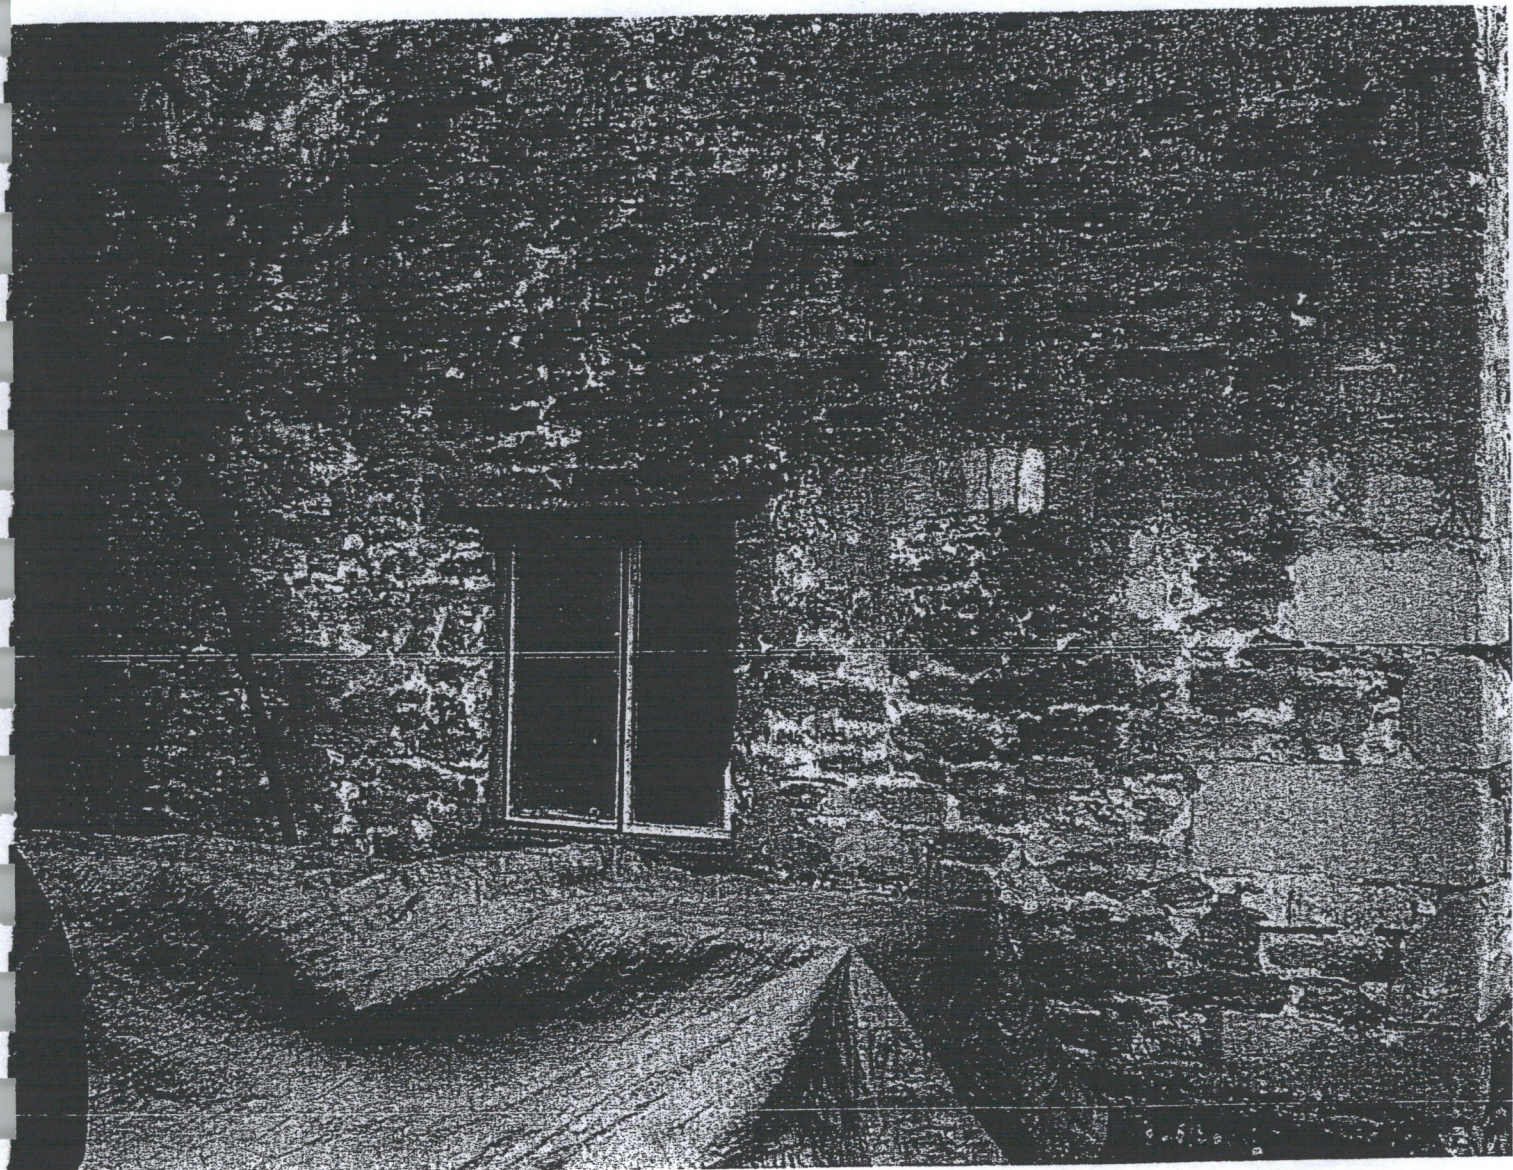
NORTH END WALL

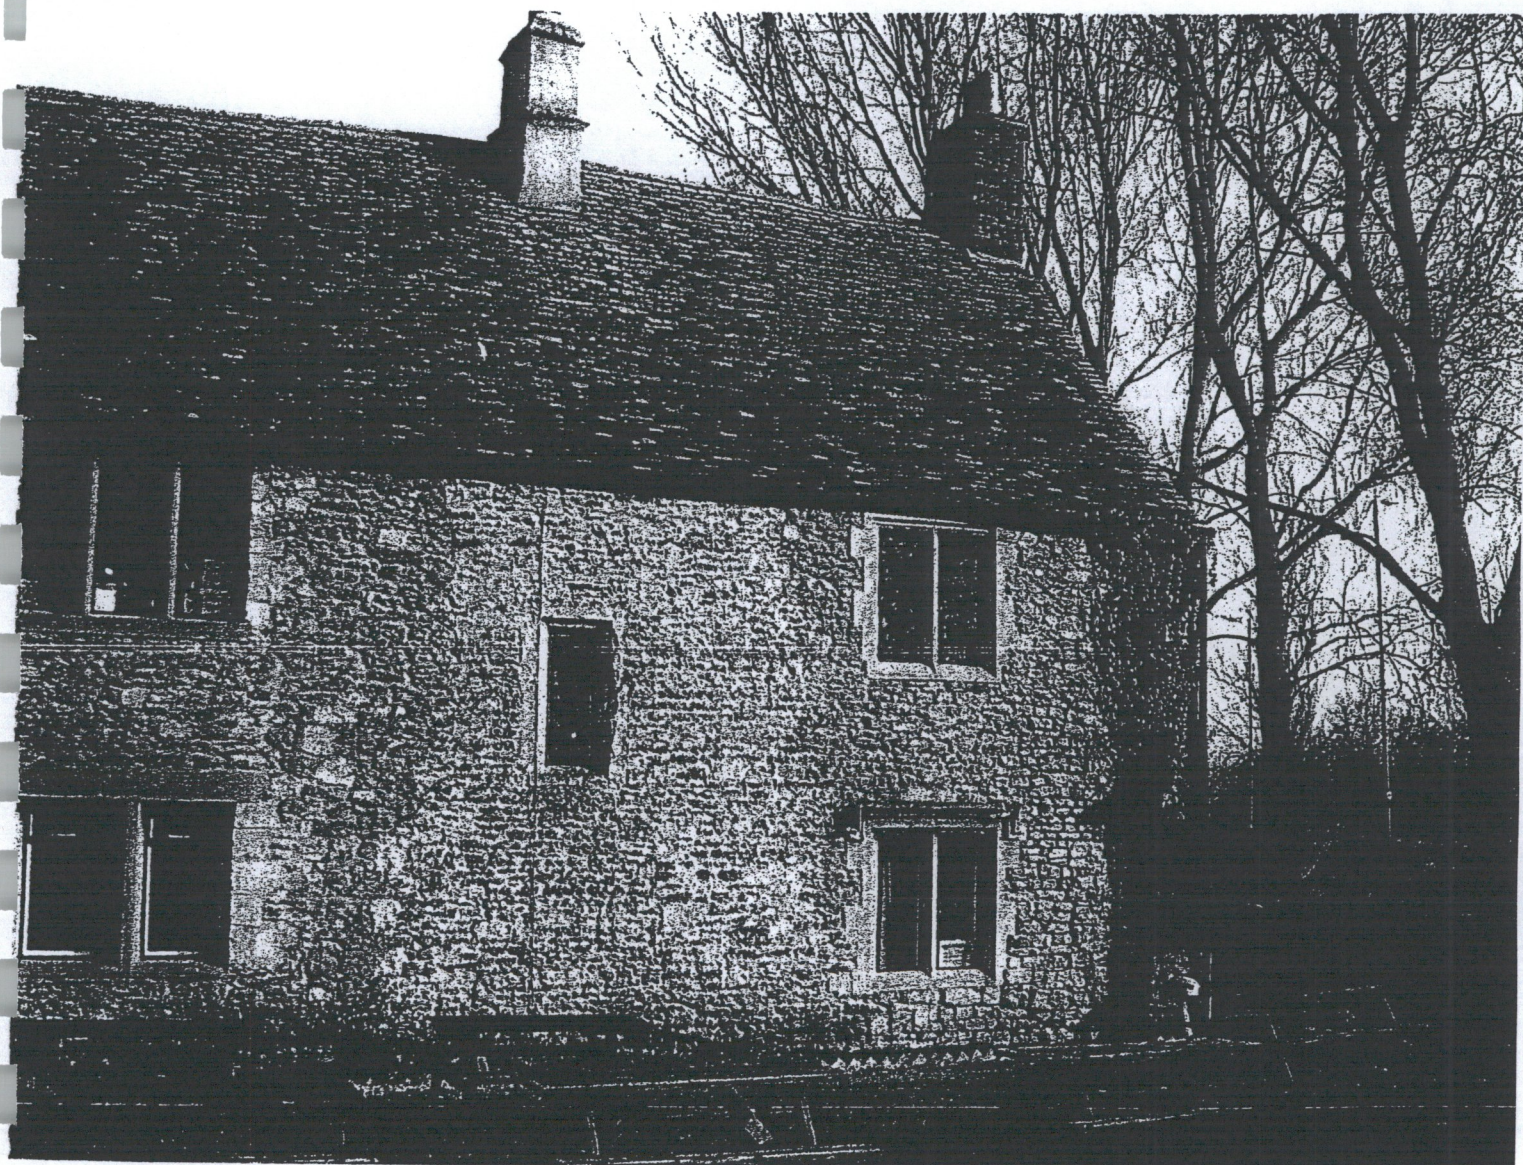
Surface discolouration due to polluted rain and from open joints with lime runs due to joint condition is visible, however, this is 'natural' staining and cleaning is not necessarily recommended as this may detract from the listed appearance. Severe staining to stonework on the east elevation has been caused by overflowing gutters and hoppers (eg see photo nos 4-7, Appendix A). At the south-western corner of the building there is a large growth of ivy which will damage to the stonework and mortar. This has grown up to gutter level and is causing the gutters to pull away from the building (eg see photo nos 8-9, Appendix A).

South West Corner

- Sensible and routine maintenance would reduce the necessity for future cleaning, repair and replacement. This should include cleaning out gutters and keeping gutters, downpipes, flashings and hoppers in good working order. Vegetation should be removed and controlled.
- Once above maintenance and repairs have been completed it is recommended that cleaning of badly stained stone is undertaken by specialist contractors.
- The ivy should be cut at base level and the roots chemically treated. The ivy itself should not be removed until completely dry and withered. It may then be carefully removed taking care to cause the least damage to the mortar as possible. Any loose or missing areas of mortar should be re-pointed as described above.

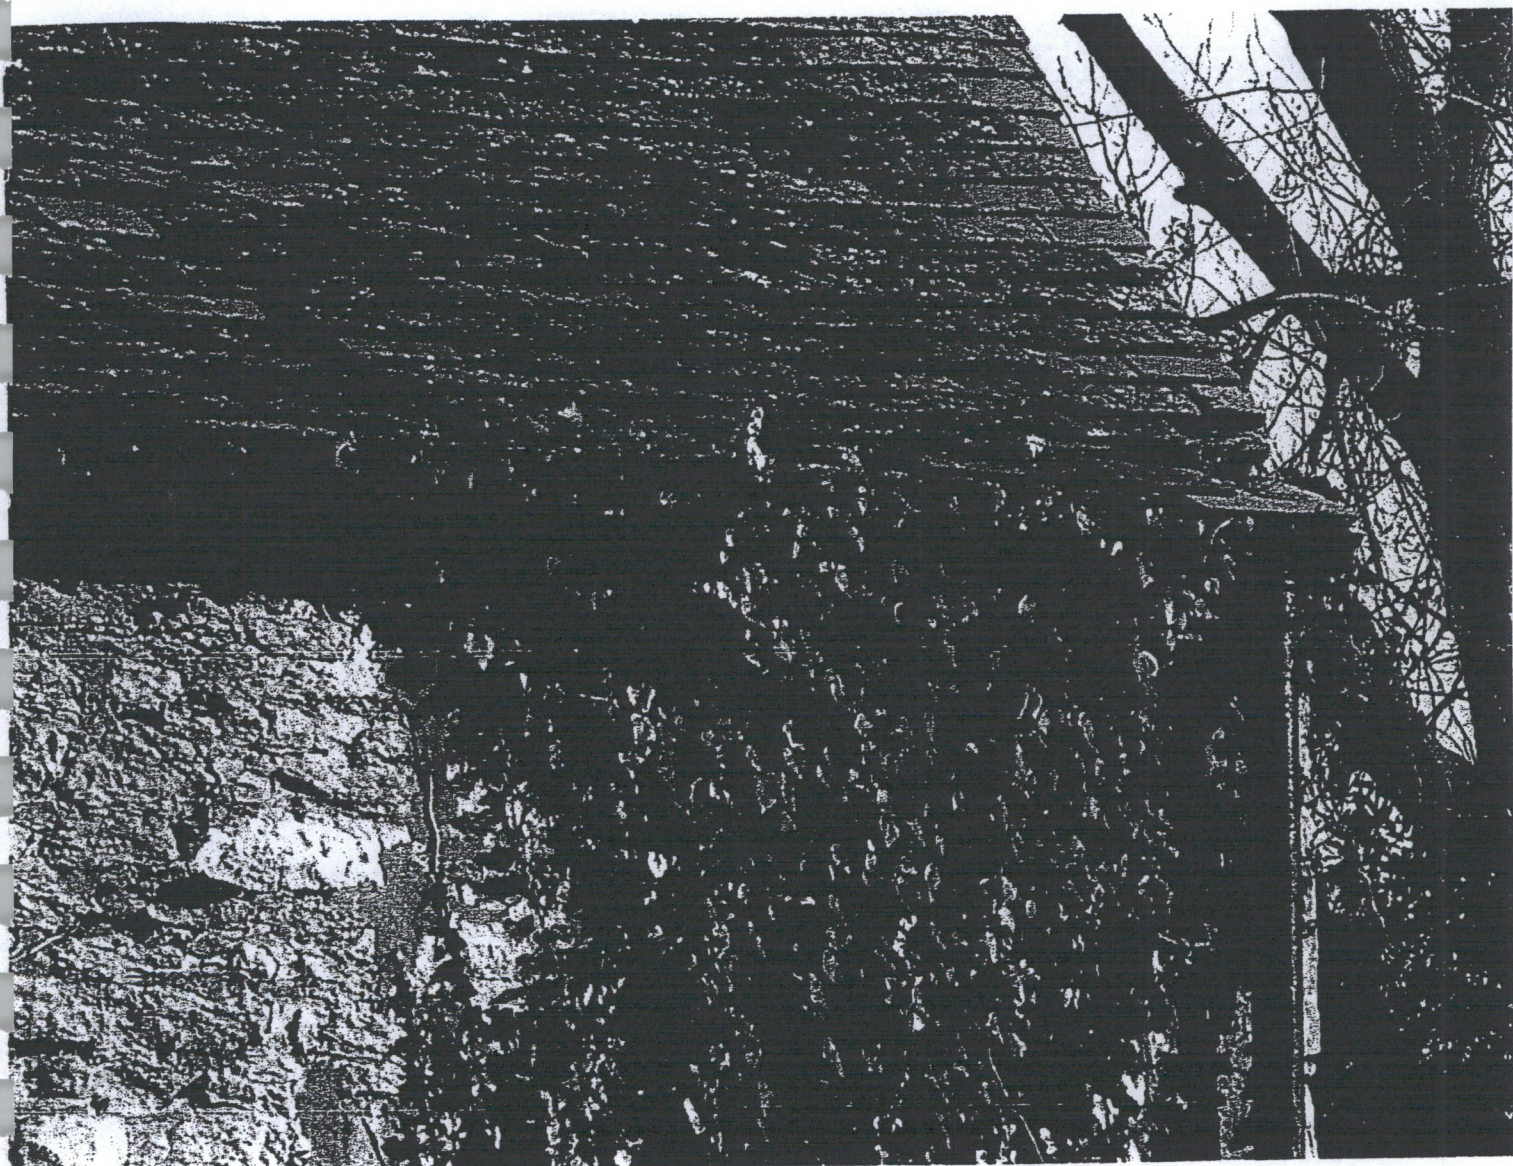
Ivy growth - South West Corner

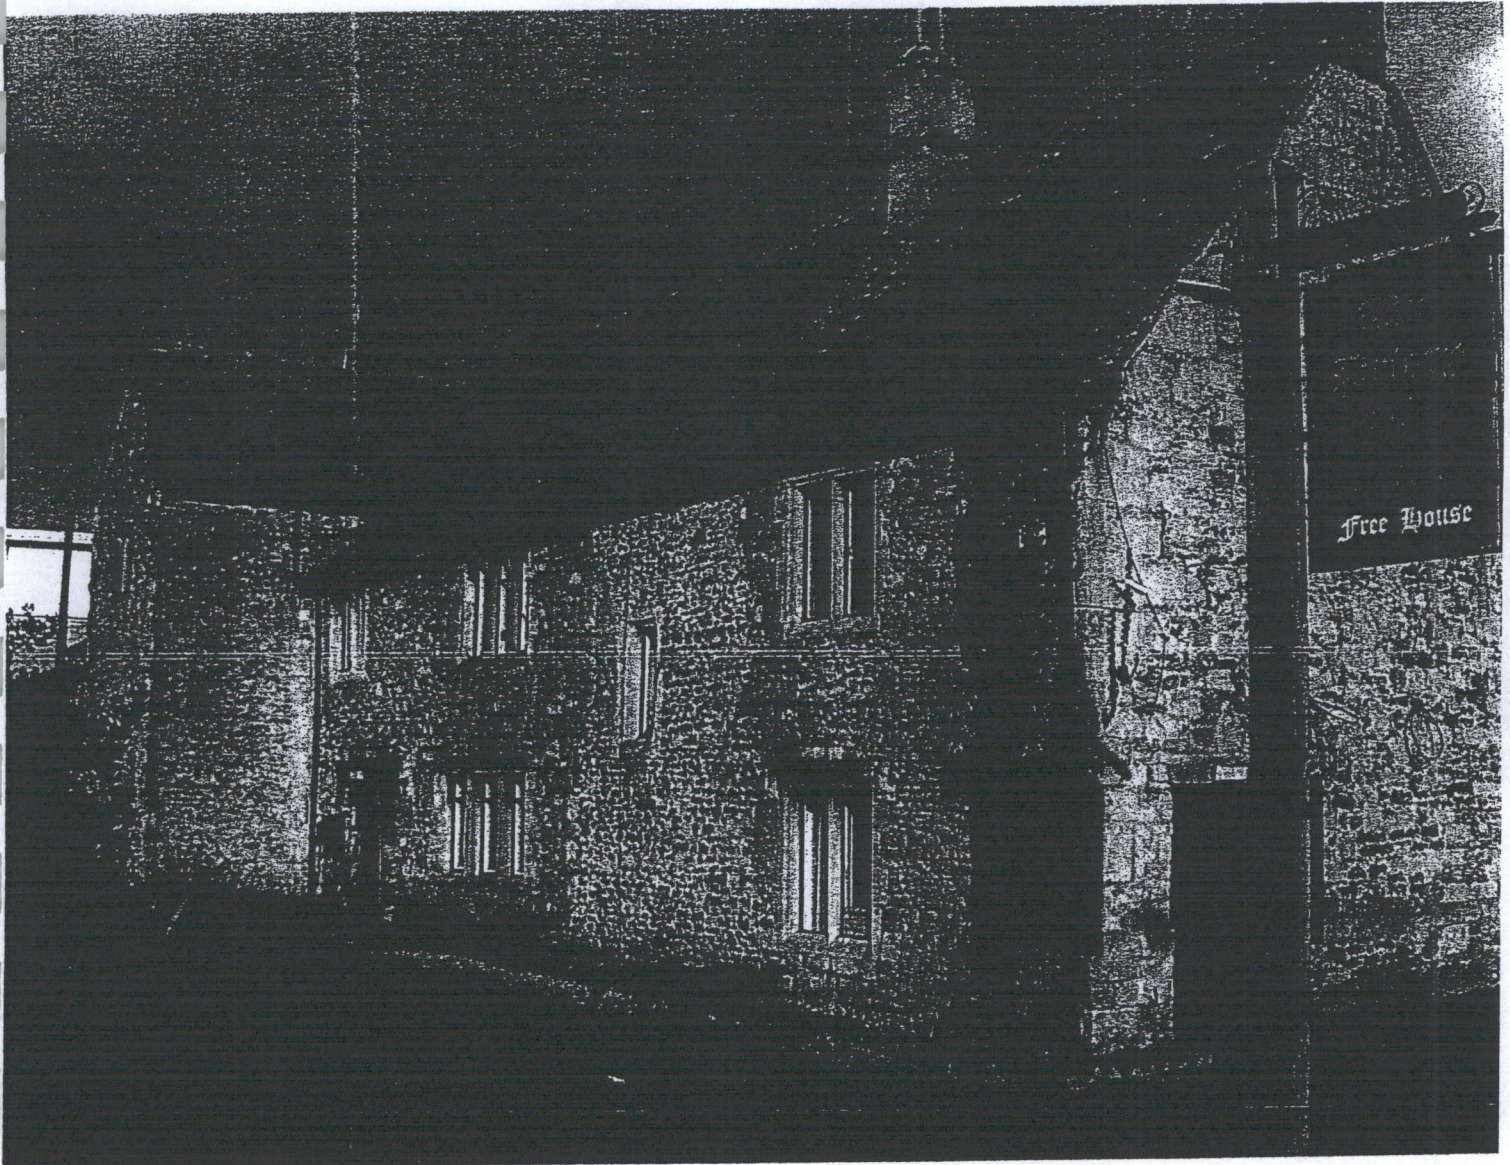
The main Priory building has a gable end pitched roof that is covered with plain clay tiles. The Western side is generally in good condition although there are a few loose and missing tiles that should be replaced (see photo no 10, Appendix A).

WEST ELEVATION

- Replace any loose and missing roof tiles.
- It is recommended that a structural engineer is employed to inspect and report on the northern end of the roof.

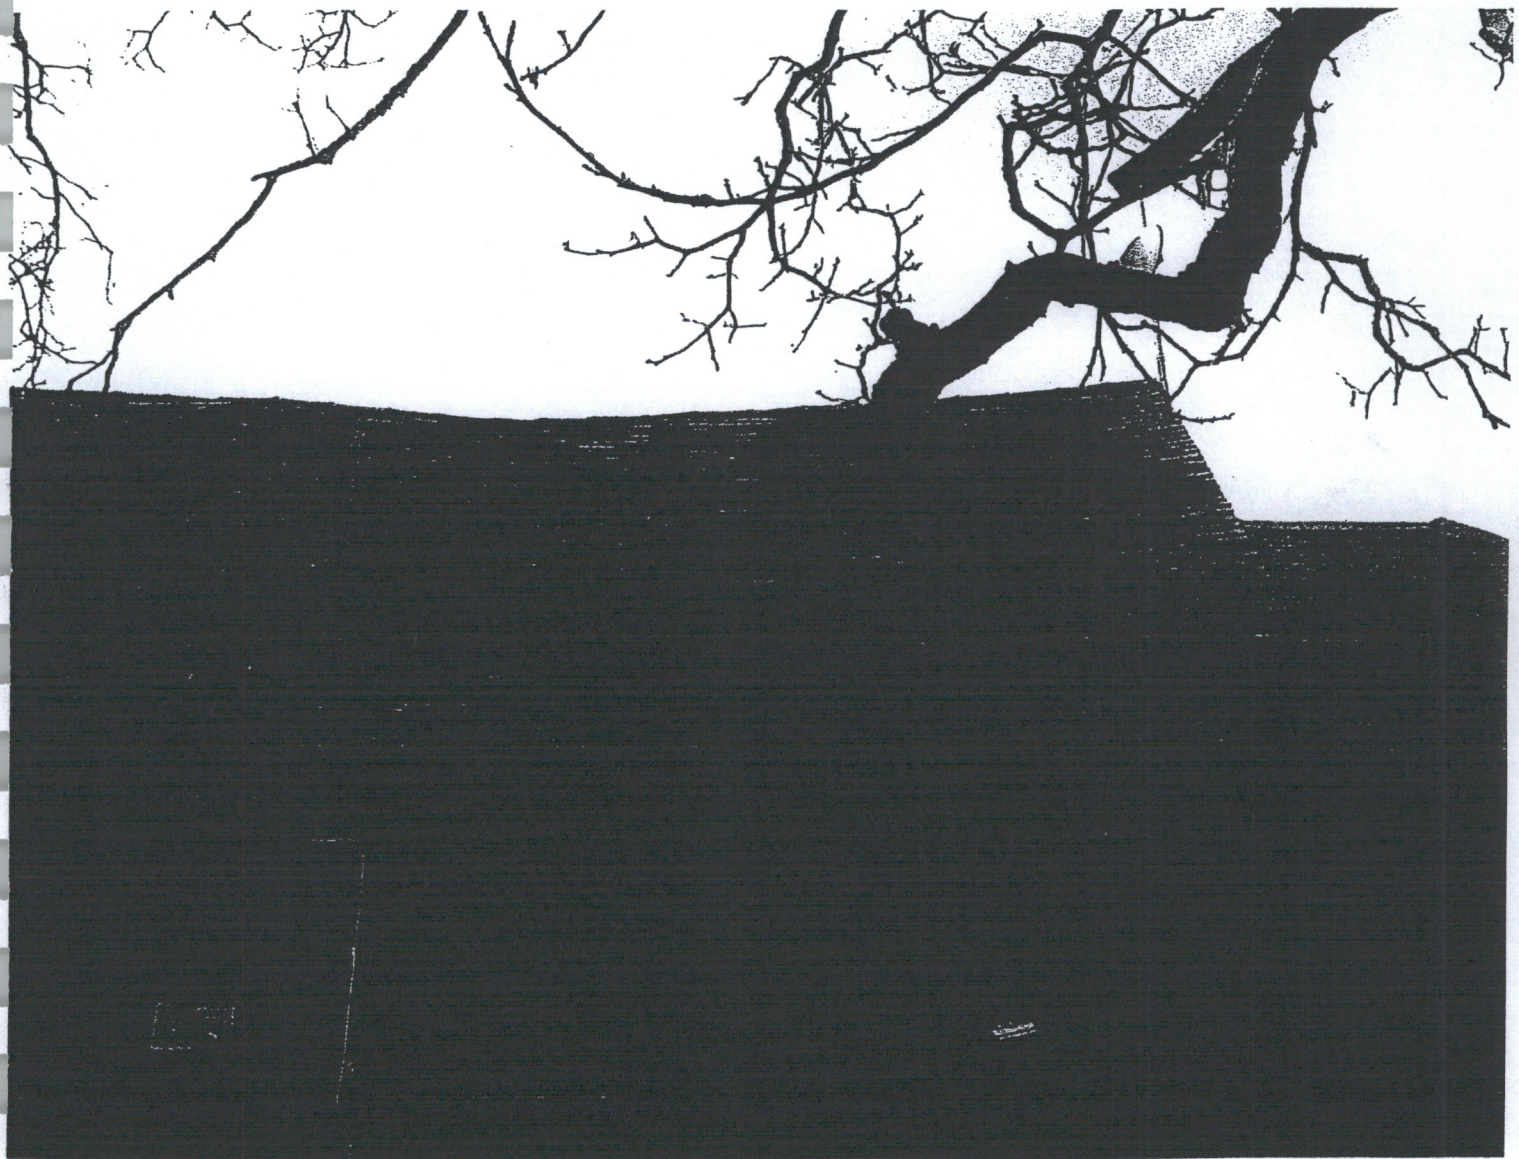
The Eastern side of the roof is, again, generally in good condition, however, there is indication of movement at the ridge towards the northern end of the roof. This may be historical or have been caused more recently by removal of an internal support. There is also movement visible around the central chimney where tiles are lifting and loose (see photo nos 11-13, Appendix A). An extensive area of moss has gathered at the lower slope below this level indicating possible damp penetration. It was not part of this investigation to inspect internally and therefore no comment can be made regarding ingress of damp or internal signs of movement within the structure.

NORTHER END OF ROOF - EAST ELEVATION

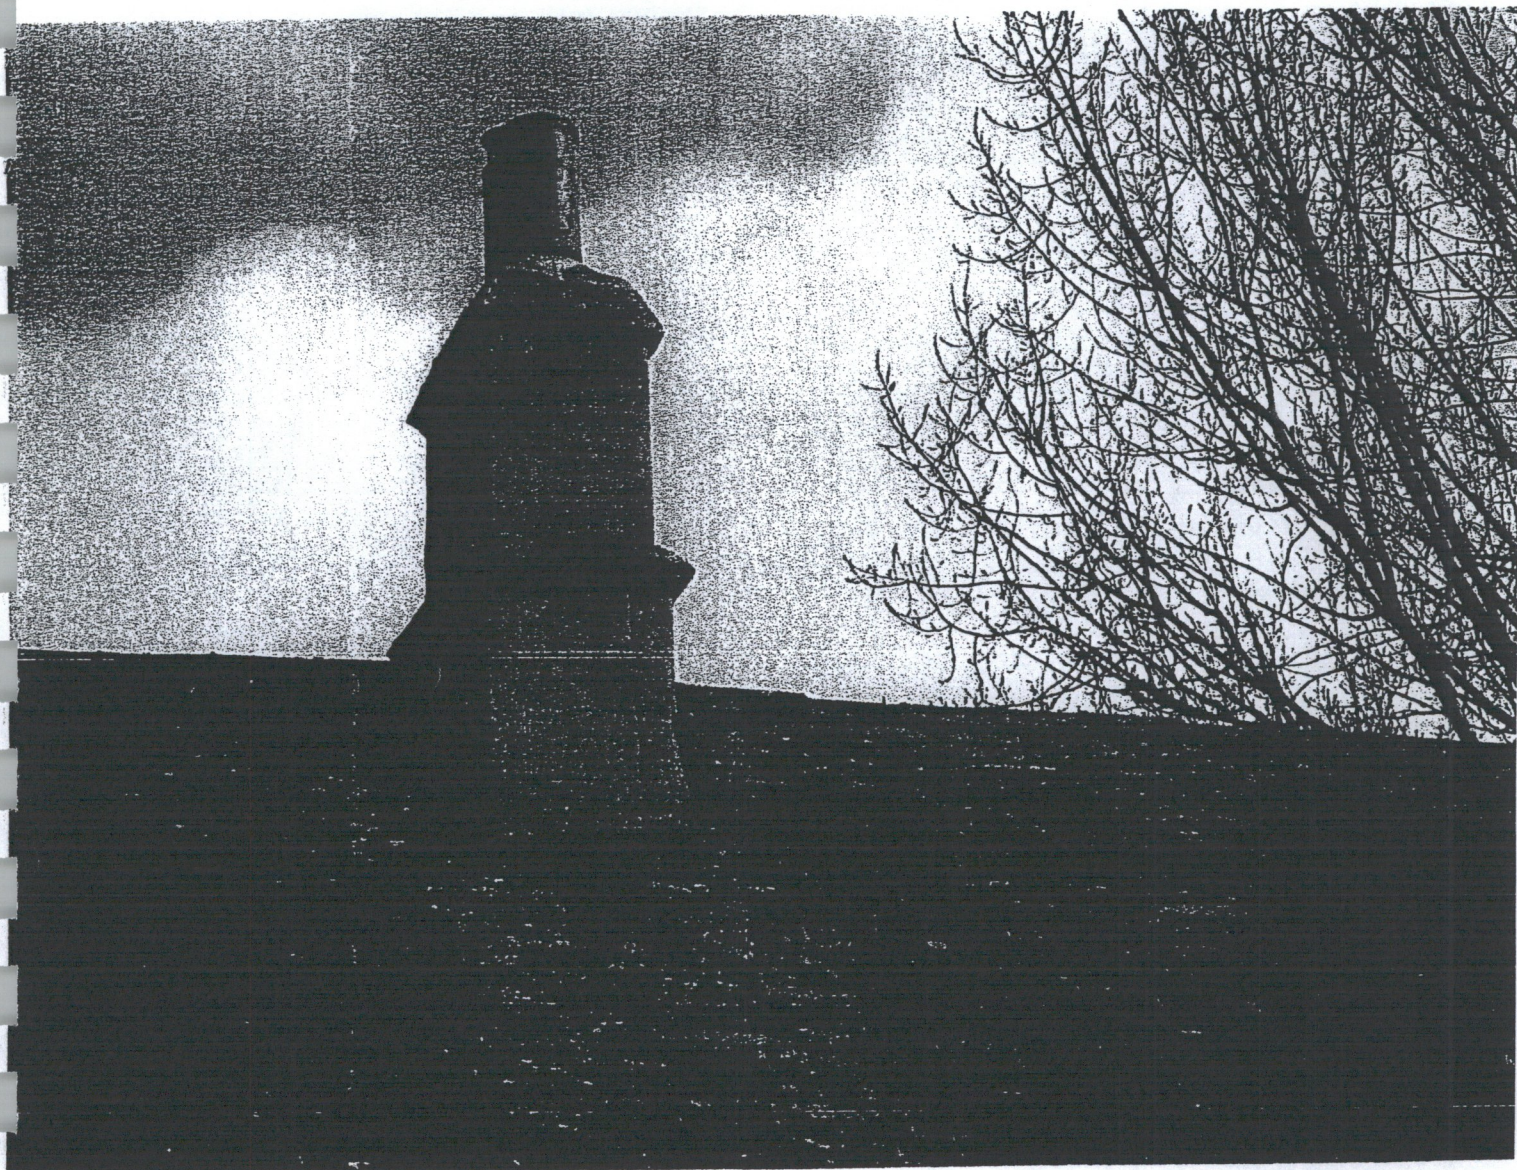
CENTRAL CHIMNEY - FROM EAST

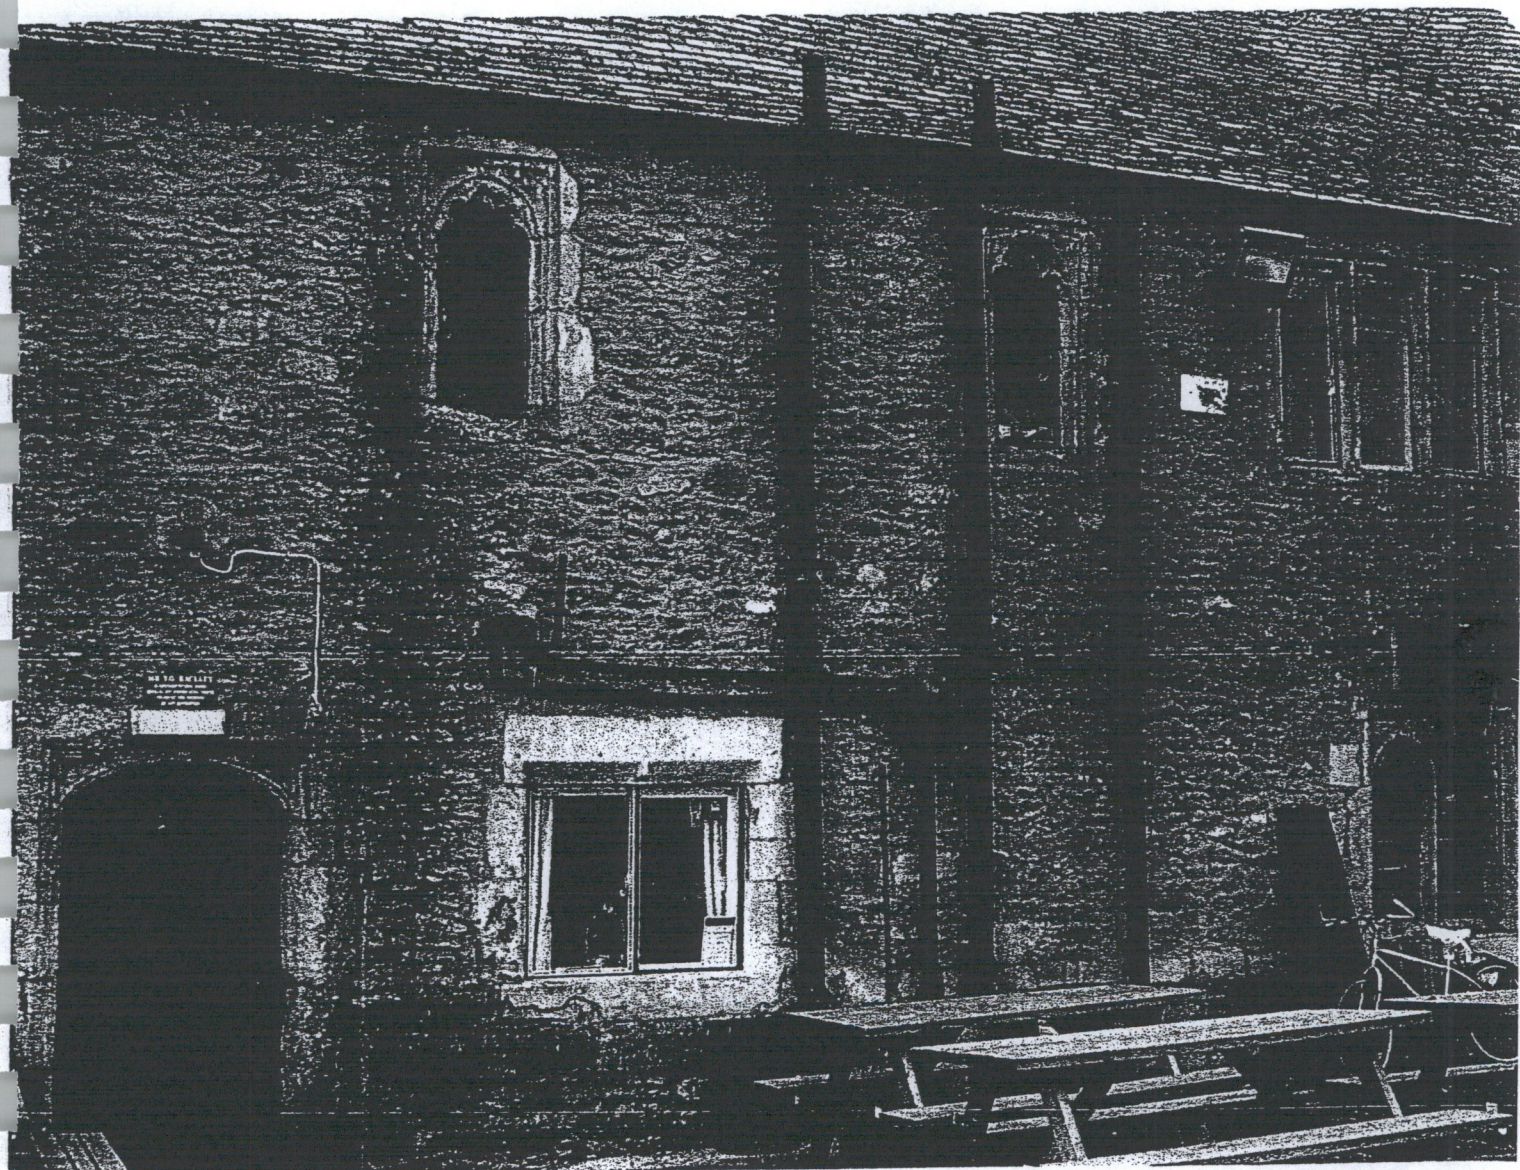
Generally all gutters and most of the external pipework is black cast iron. A small amount of black plastic wastes discharge over a cast iron hoppers on the east elevation. The hopper to the left of the entrance door is loose and requires fixing. Although not particularly aesthetic the pipework is in sound condition (see photo nos 14-15, Appendix A).

External pipework - East Elevation (1)

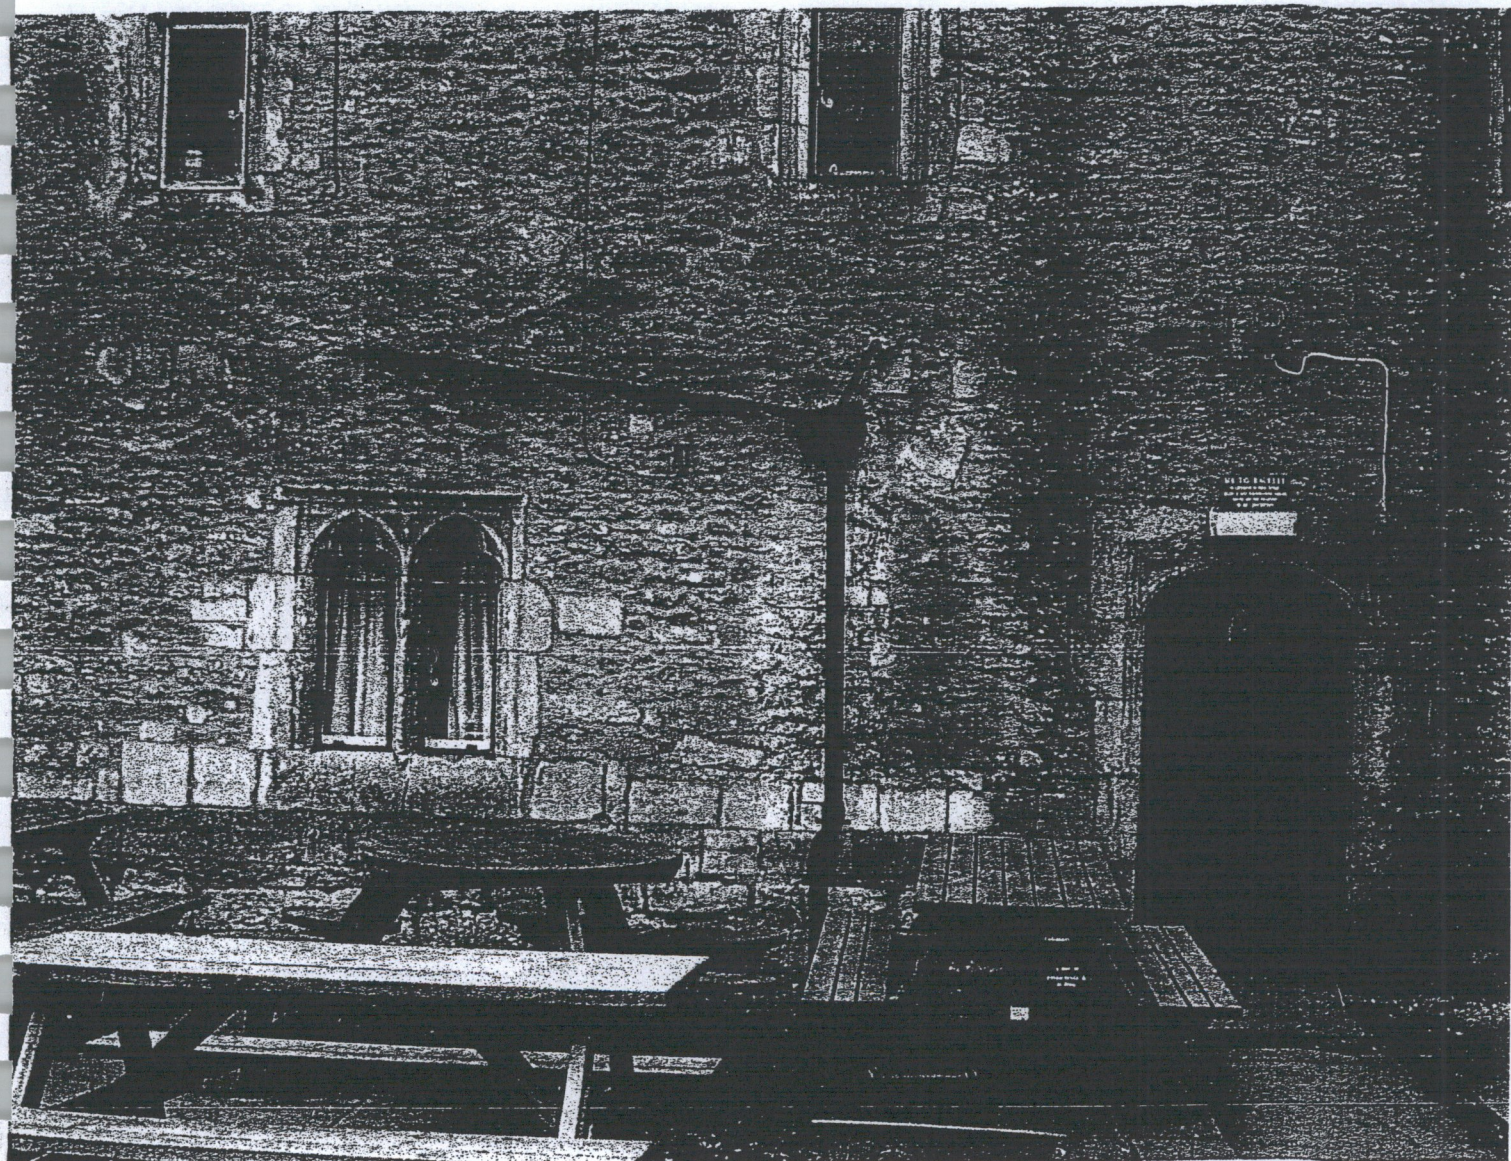
External pipework - East Elevation (2)

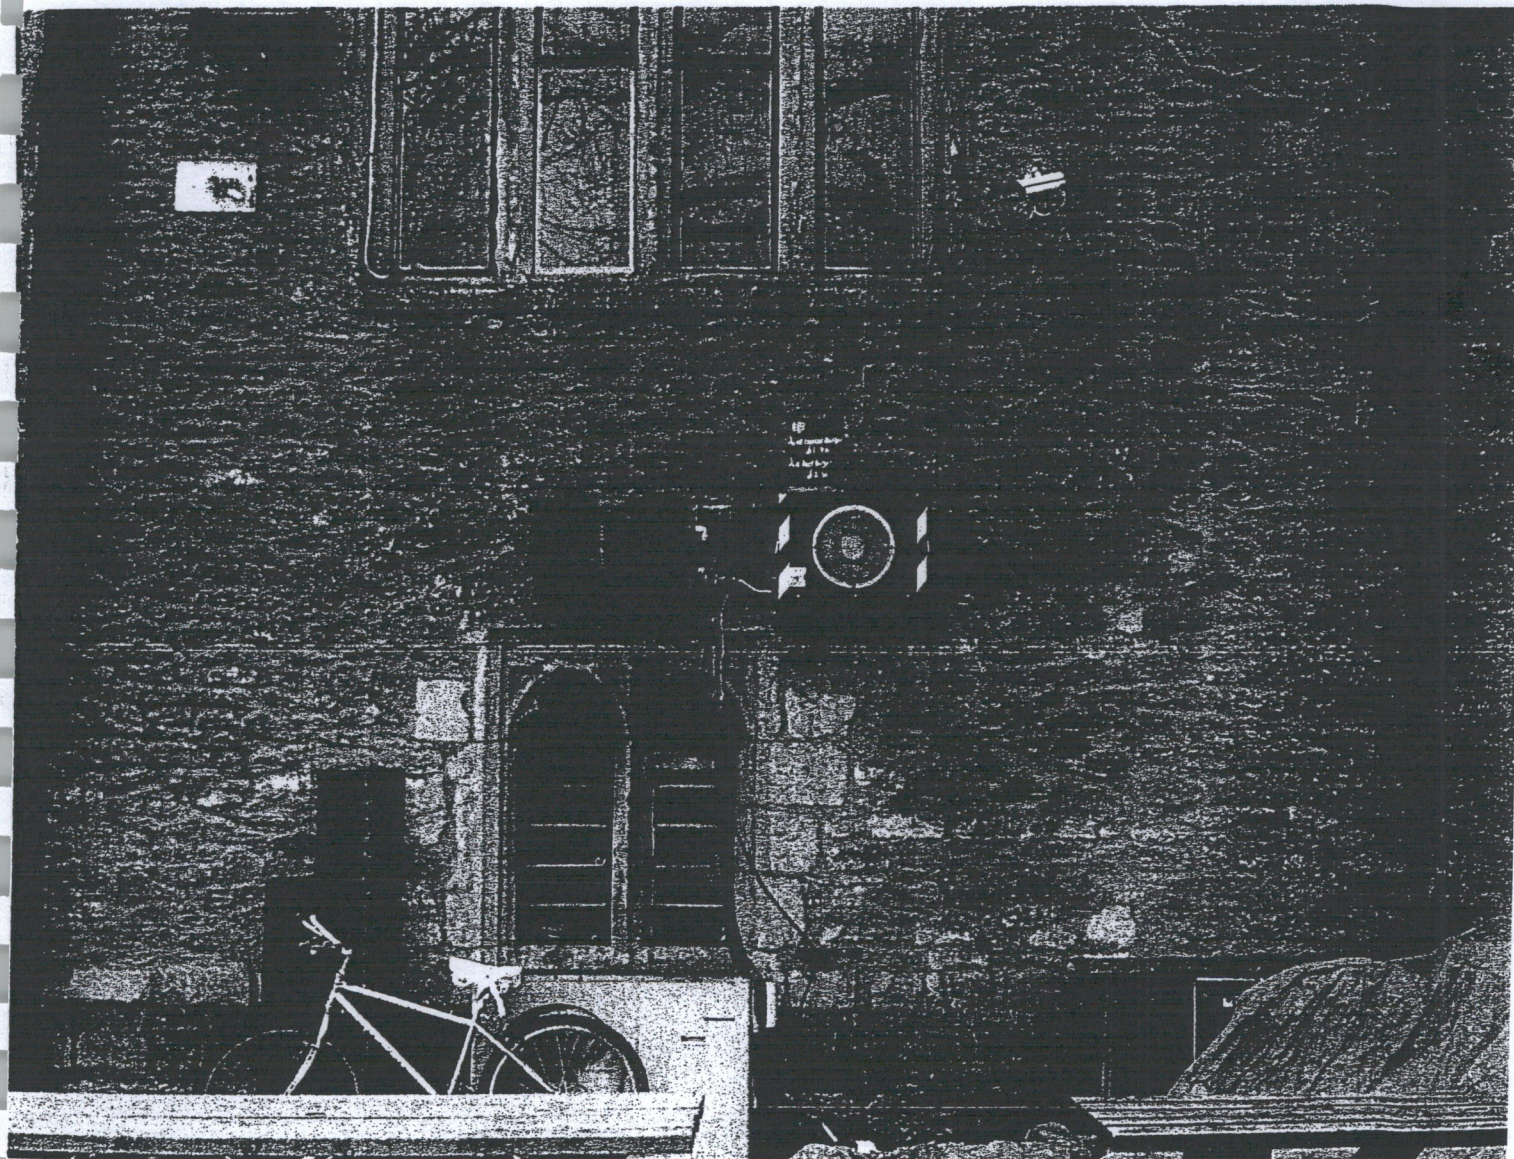
Photo no 16 (Appendix A) indicates two extract units and associated wiring serving the bar and cellar areas of the public house. Should these be removed in the future careful repairs will be necessary to both the wall and the window.

EXTRACT UNITS - EAST ELEVATION
