**GALLIARD HOMES**

**OXFORD STADIUM  
SANDY LANE, COWLEY**

**HERITAGE ASSESSMENT**

**11 APRIL 2013**

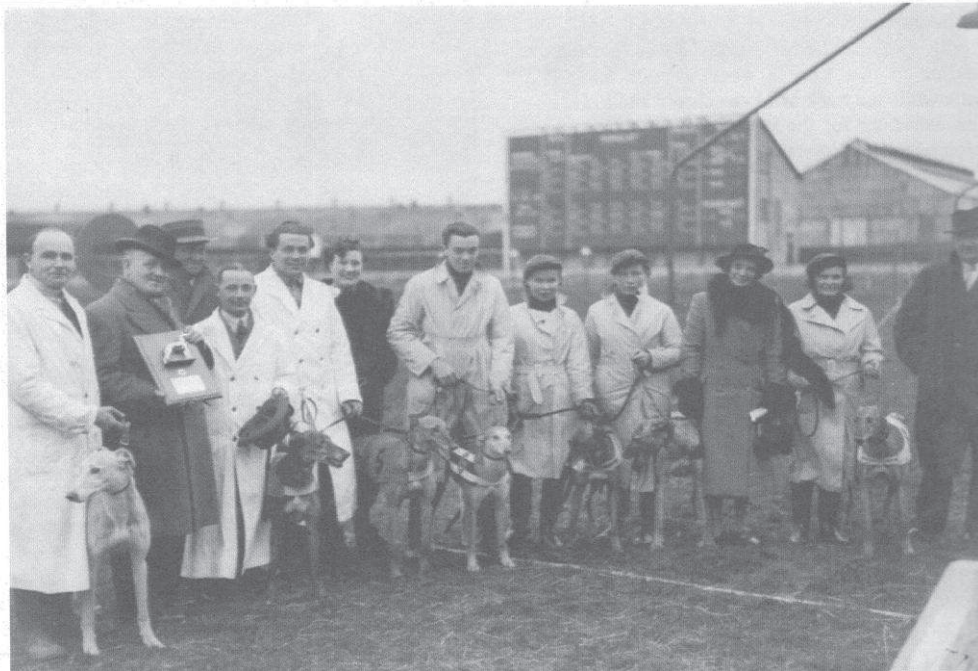
**Fig 5: Totalisator building in 1941**

- 3.17 A photograph of January 1941 shows the totalisator in the distance (**Fig 5**). The photograph indicates the window on the south flank wall but the external stepped access to the upper floor is not visible.

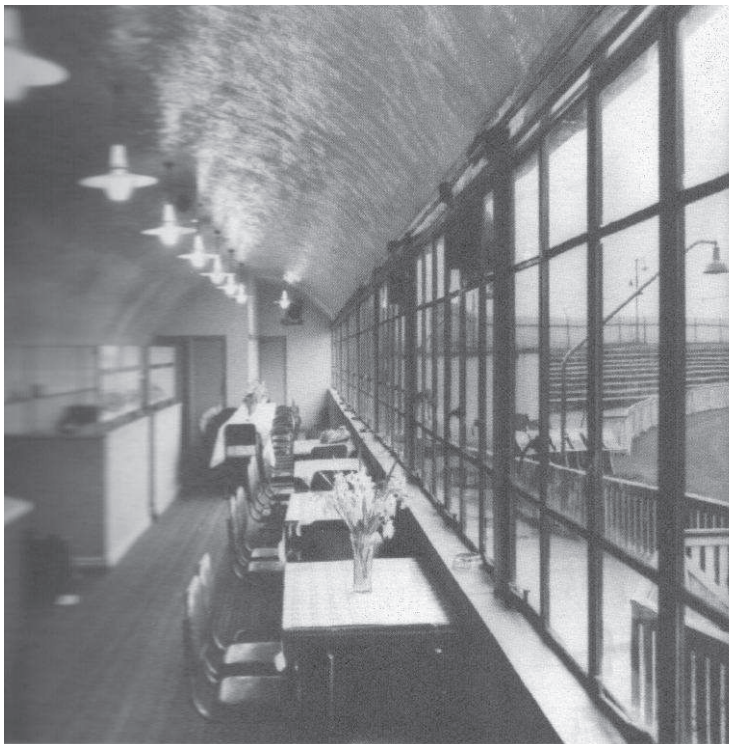
**Fig 8: Former Director's Bar in 1959 (from Baiden)**

- 3.23 The 1955 OS map illustrates the layout of the stadium (see CgMs report, Figure 6). Although showing a similar layout to that of the 1940s plan there are significant differences. The main stand and club had been replaced following the fire in 1942, the Director's Bar close to the main entrance had been built, the terrace on the railway side had been extended and more buildings added to the rear of the main western terrace. Temporary or wooden stands are indicated on the map by broken lines. Photographs of the totalisator and the Director's Bar dating to 1959 are reproduced in Baiden and in this report (**Fig 7 and Fig 8**). The Director's Bar

appears to be the long “Nissen” type building which survives on site but has been significantly extended.

- 4.17 The former Director's Bar resembles a small elongated Nissen hut. It was extended to the front, which doubled the size of the structure. The structure is glazed to the front to allow trackside views. The rear part is of concrete blocks with a corrugated iron roof. It has been much altered internally. The poor quality of construction and materials used are evidenced by its poor condition. It is of no aesthetic value.

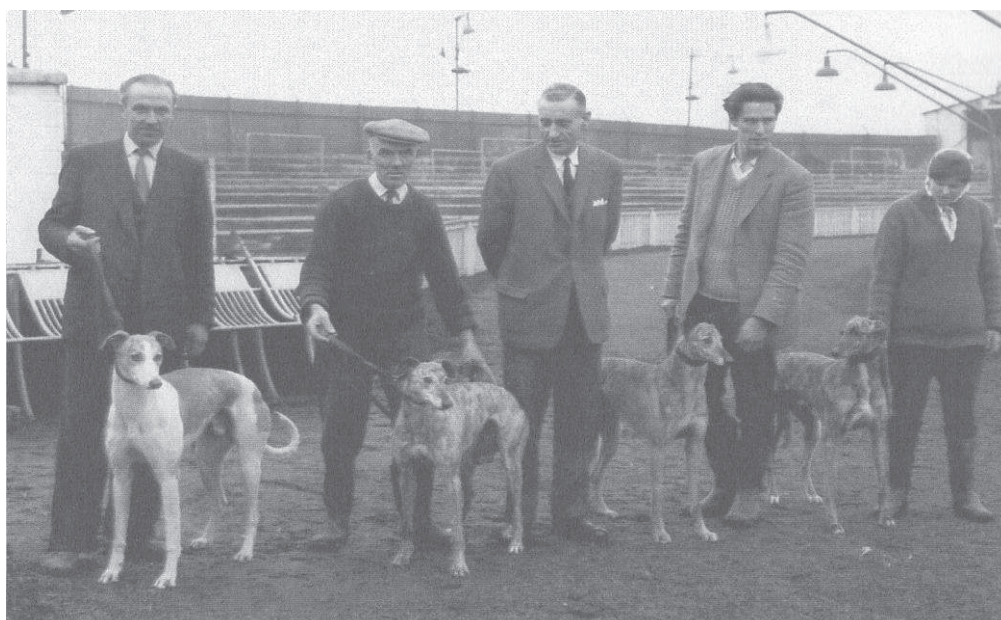
**Fig 9: Resident trainers in front of western terrace in 1964 (from Baiden)**

- 3.26 In January 1963 stadium staff worked all day to clear over two feet of snow from the track so that the meeting could go ahead (Oxford Mail, 24.07.1976). A photograph of 1964 shows the resident trainers with greyhounds in front of the western terrace (see **Fig 9** and Baiden, p. 27).

- 4.15 The western curving terrace either side of the entrance through to the former paddock, now a car park, is of simple concrete and block construction. The poor quality of concrete is showing its age and is crumbling and broken. The block constructed entrance to the former paddock has no aesthetic value. The terrace is typical of the period. The terrace has no aesthetic value.
- 4.16 The single storey buildings west of the terrace appear to have been used by the speedway teams in latter years. The single storey buildings have no aesthetic value and the paddock was converted to a car park many years ago.

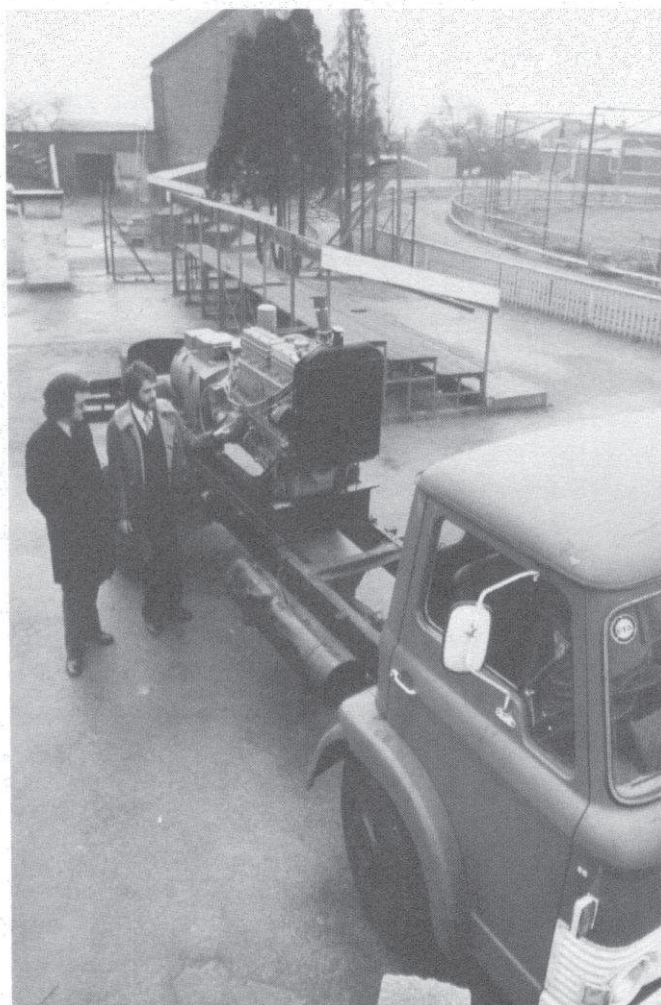
- 3.32 The national power crisis of 1973 resulted in the installation of an emergency generator, illustrated in Baiden, p. 37. This photograph taken to the south of the kennels looking towards the totalisator provides a glimpsed view of the north flank wall of the building (see **Fig 11**). Unfortunately the windows on the flank wall are obscured by trees (no longer in place). The photograph also shows the temporary wooden stands that were located either side of the walkway between the kennels and the starting traps.

**Fig 11: Totalisator building and temporary generator in 1973 (from Baiden)**

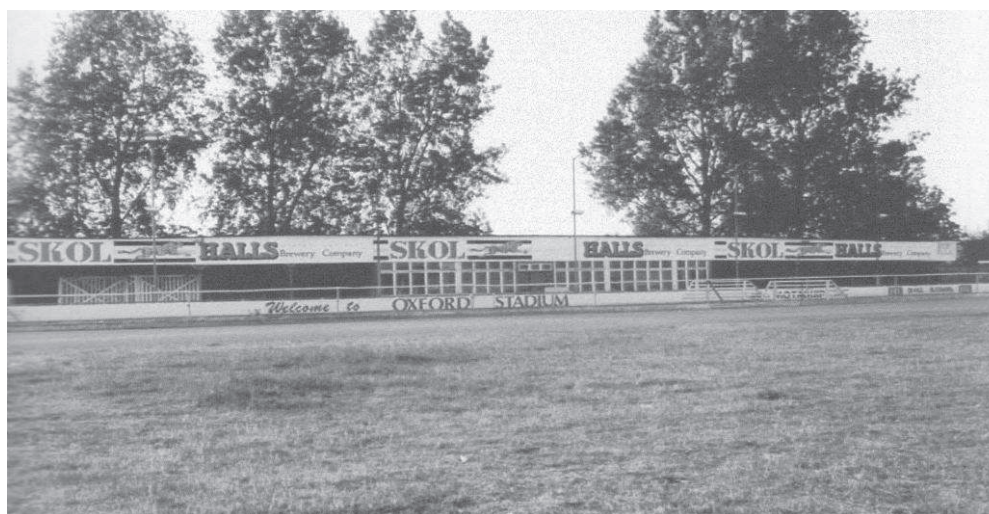
**Fig 12: North stand prior to demolition in 1990 (from Baiden)**

- 3.41 In 1989 the centre green was converted for use as an American Football pitch (Baiden, p. 57).
- 3.42 In 1990 planning permission was obtained for the demolition of the north stand and its replacement with a single storey stand (OCC ref: 90/00485/NF). A photograph of the stands prior to demolition is presented in Baiden, p 44, and reproduced in this report at **Fig 12**.

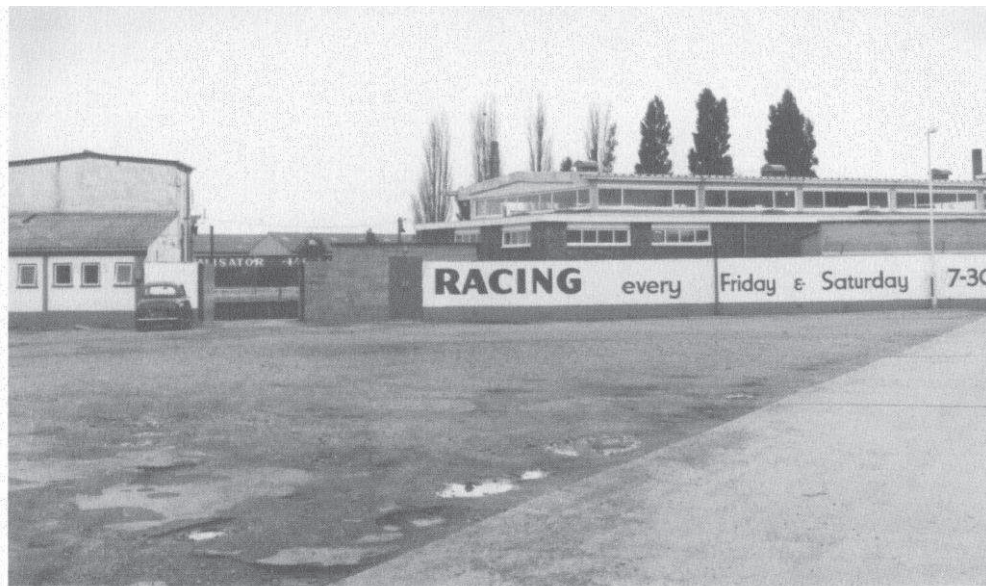
**Fig 13: The entrance to the Stadium from Sandy Lane in the 1960s**

- 3.47 The development resulted in the demolition of the old supporters club. The new development was completed on 18 March 2000. Further investment included £130,000 spent on a new track surface and hare system. **Figs 13 and 14** show the Stadium from Sandy Lane before the redevelopment.

- 4.46 When accessing the site from Sandy Lane there is no dramatic sense of arrival. It is rather understated. What one sees is the new buildings rather than the racetrack. It could be any other facility, there is nothing to distinguish it as a greyhound stadium. This is in stark contrast to Walthamstow Greyhound Stadium which advertised its presence and was very visible to travellers using the North Circular Road around London. Even before the redevelopment of the main stand at Oxford the entrance to the stadium was understated as can be seen in figs 13 and 14 of this report.

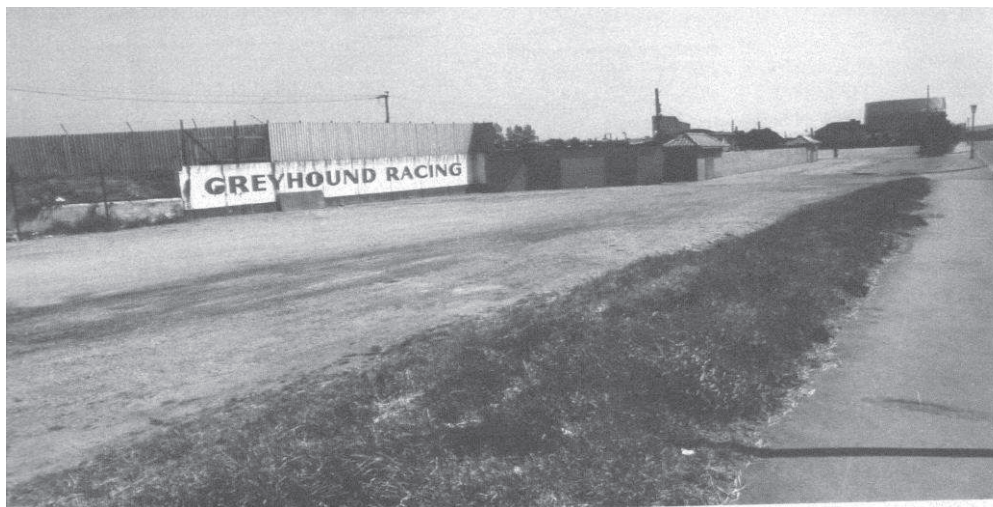
**Fig 14: The Stadium from Sandy Lane before the main stand was redeveloped**

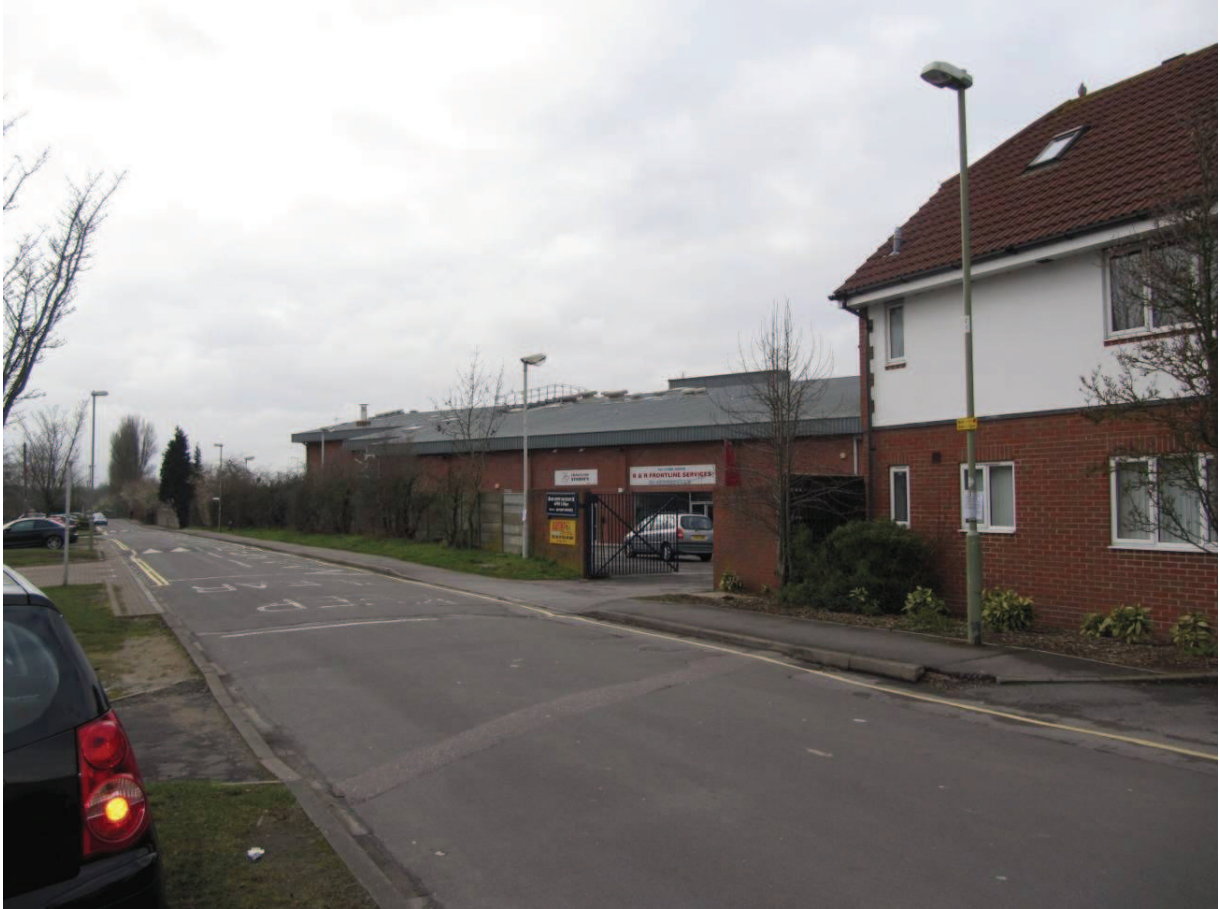
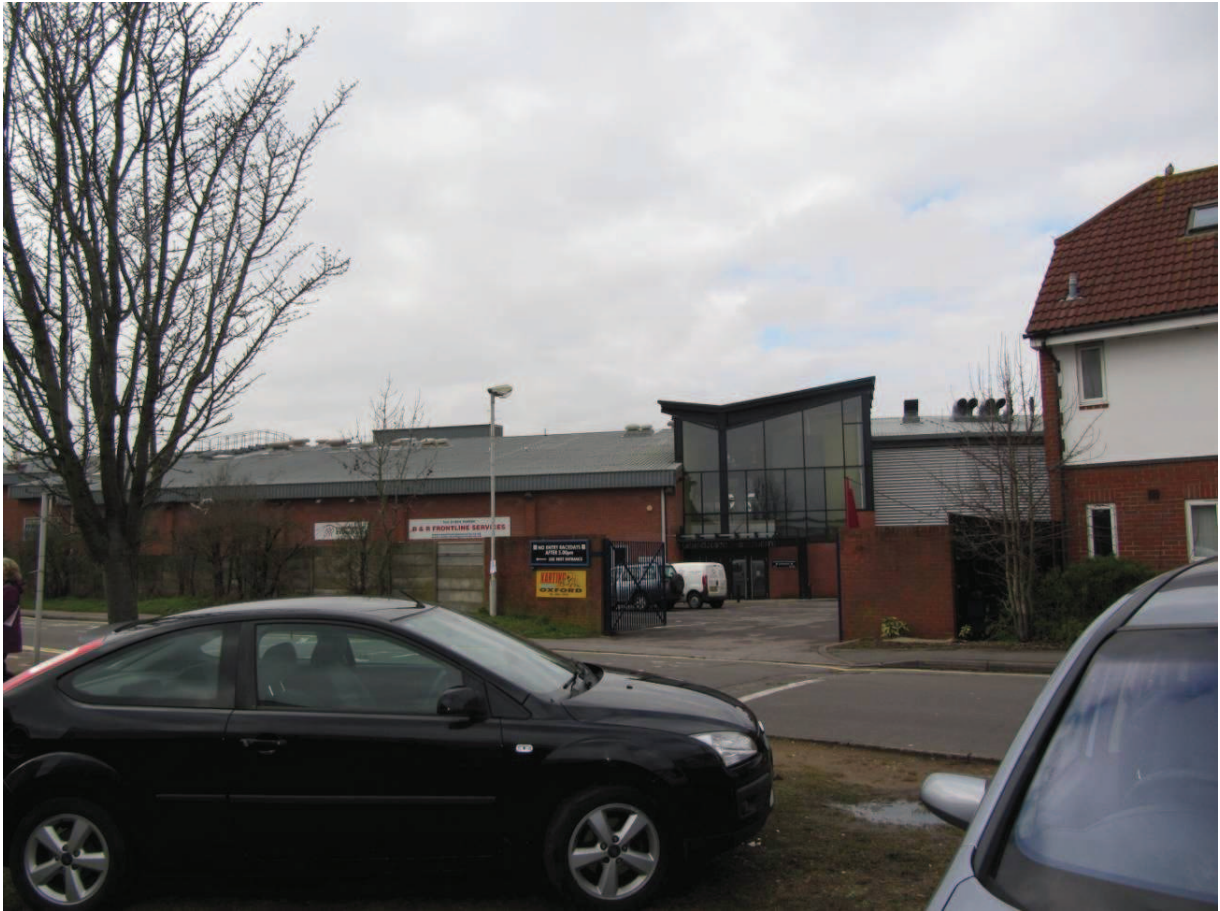
2.2 The main stand of the stadium is located on the south side of the track and is visible from Sandy Lane, set back behind a car park (**Photographs 1 and 2**). It is faced in red brick with a grey synthetic roof. The main elevation of the building facing the south side of the greyhound racing track is largely faced with glazed panels (**Photograph 3**). The interior of this 1980s building was not inspected.

**Photograph 1 – rear of main stand from Sandy Lane**

Photograph 2 –rear of main stand from Sandy Lane

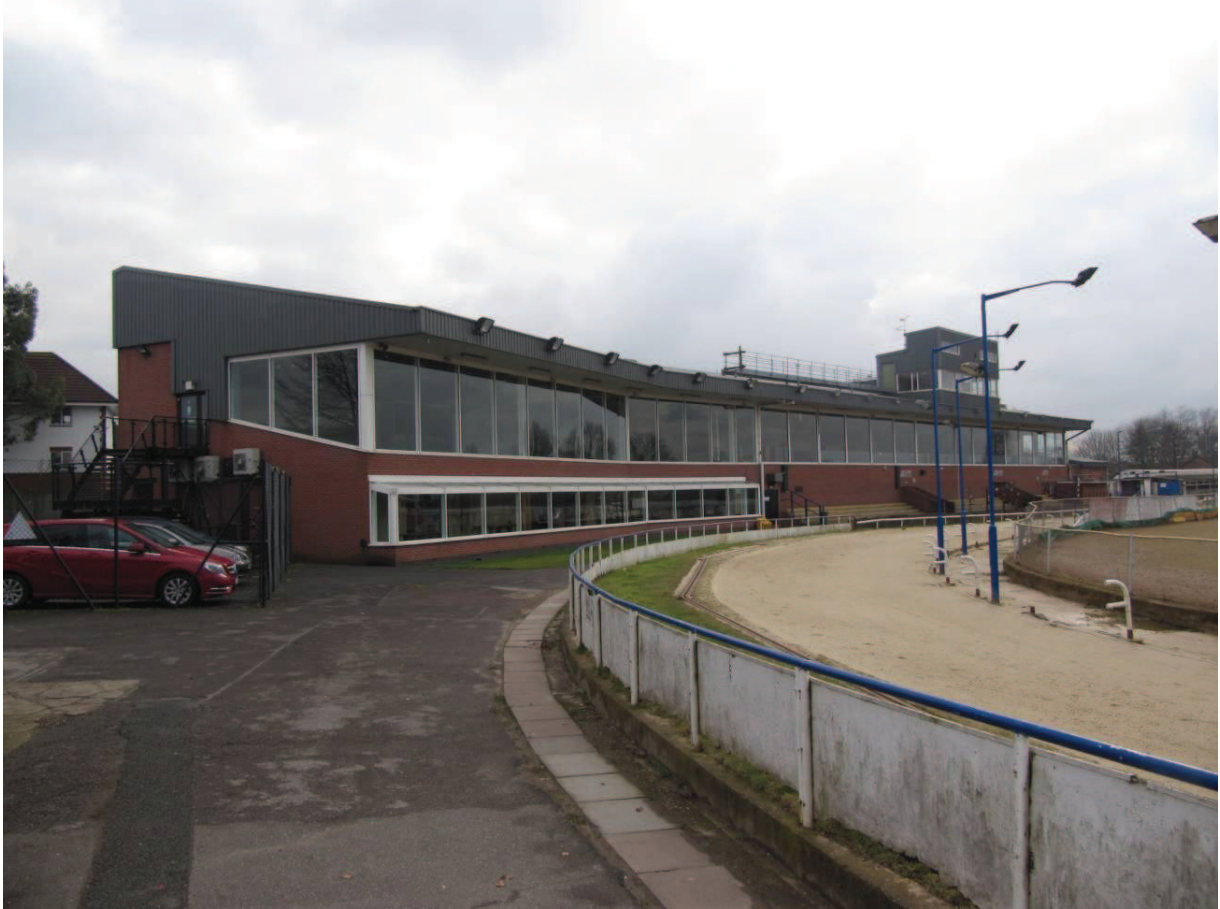
**Photograph 3 – front of main stand**

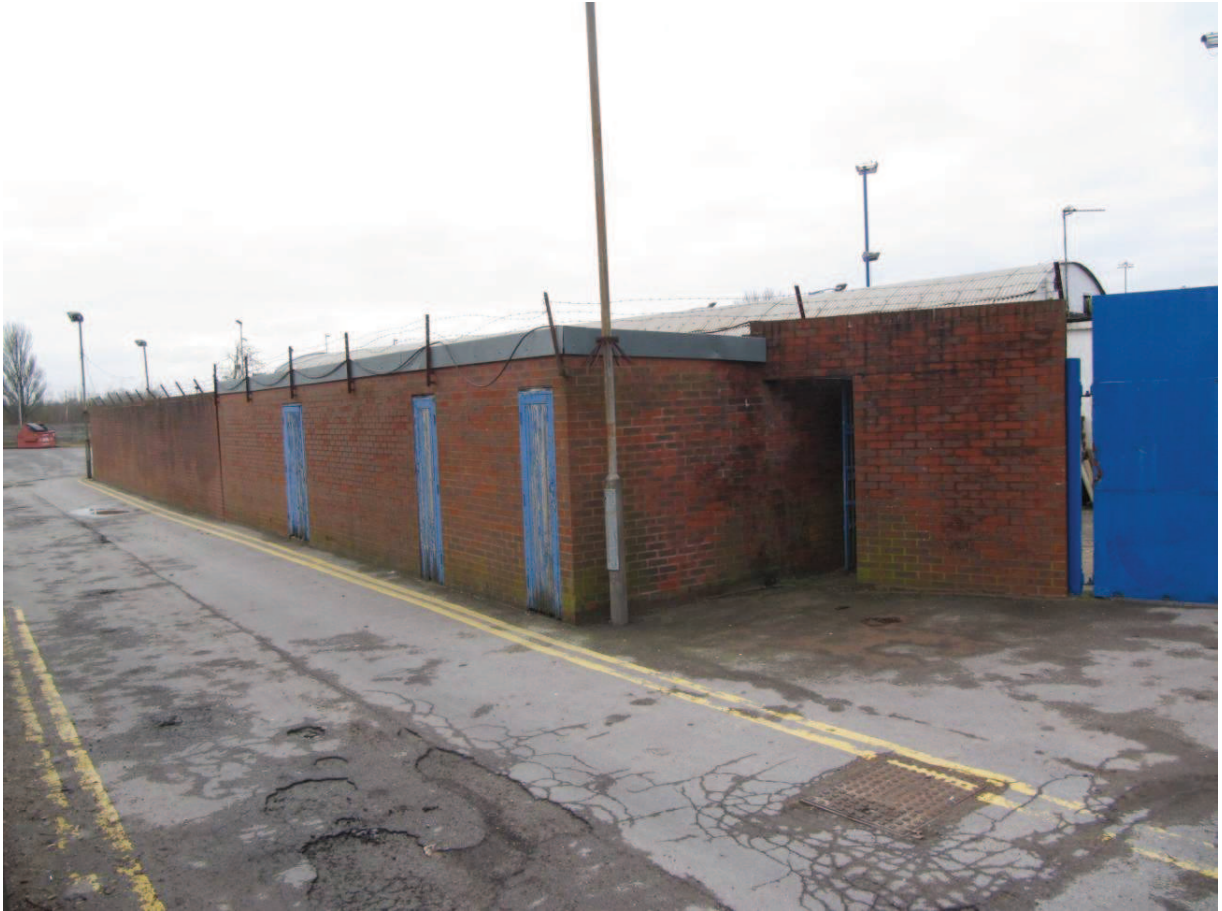
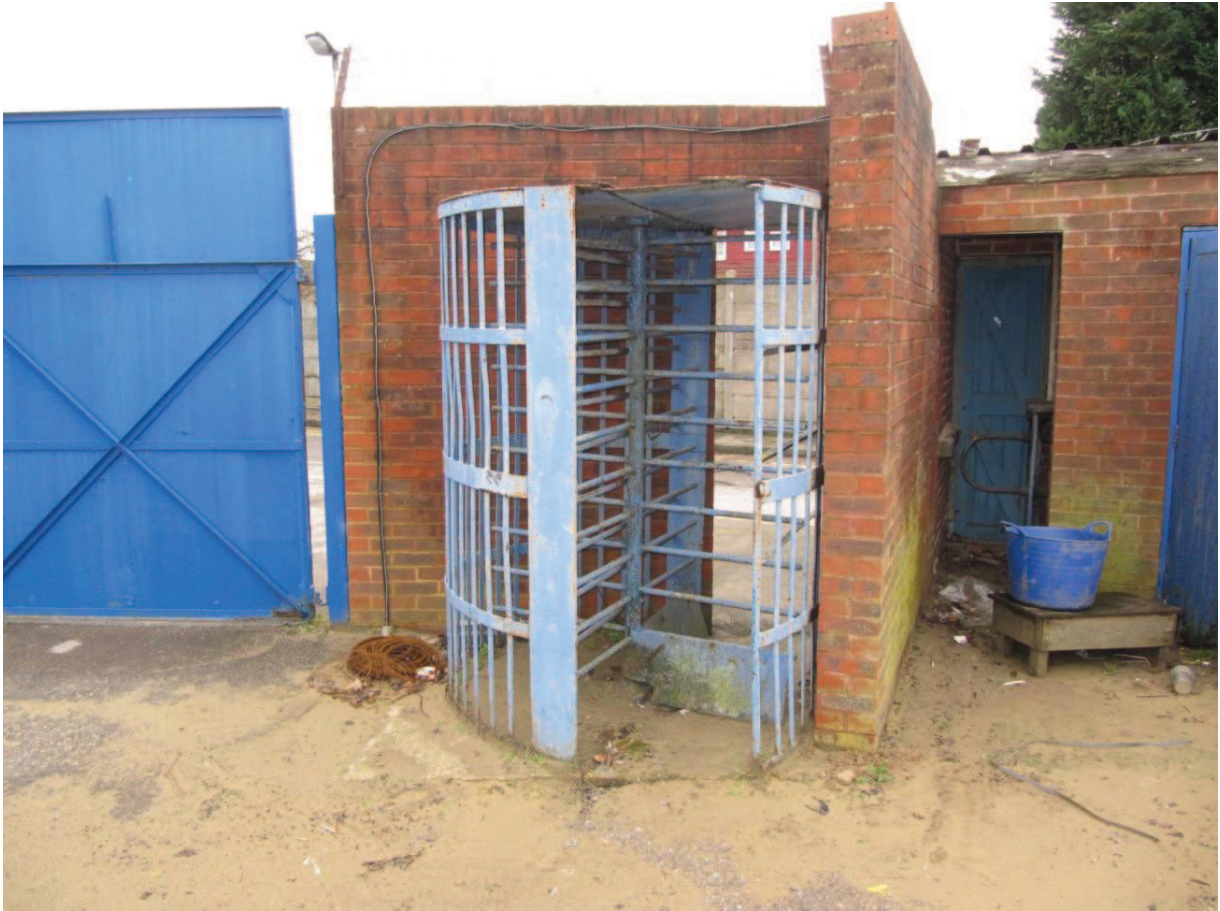
2.3 Red brick walls contemporary with and adjacent to the main stand provide a pedestrian entrance to the stadium via a turnstile (**Photographs 4 and 5**).

**Photograph 4 – turnstiles**

Photograph 5 – turnstiles

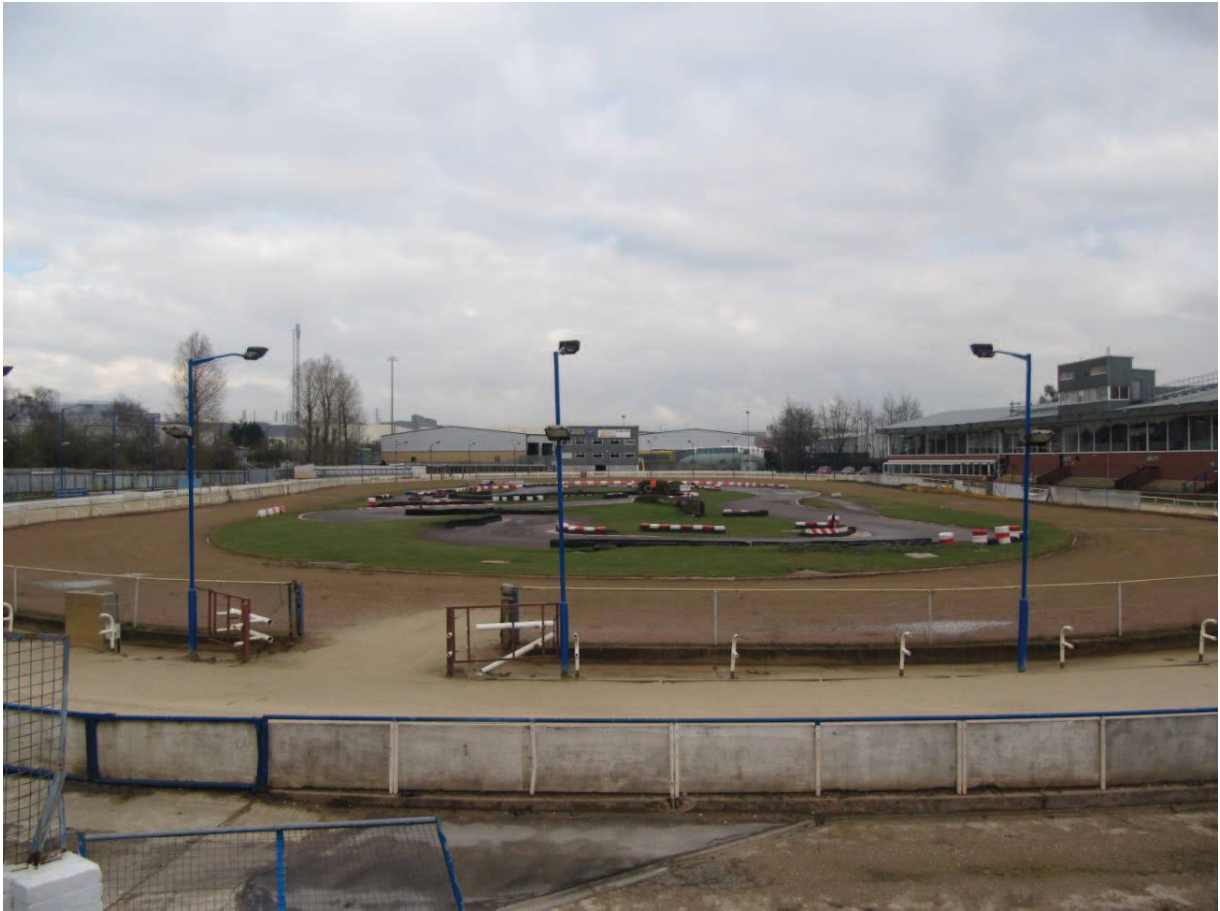
2.4 The greyhound racing track includes modern lighting and fences, and has a go-kart track at its centre (**Photograph 6**).

**Photograph 6- greyhound racing tract with go-kart track to centre**

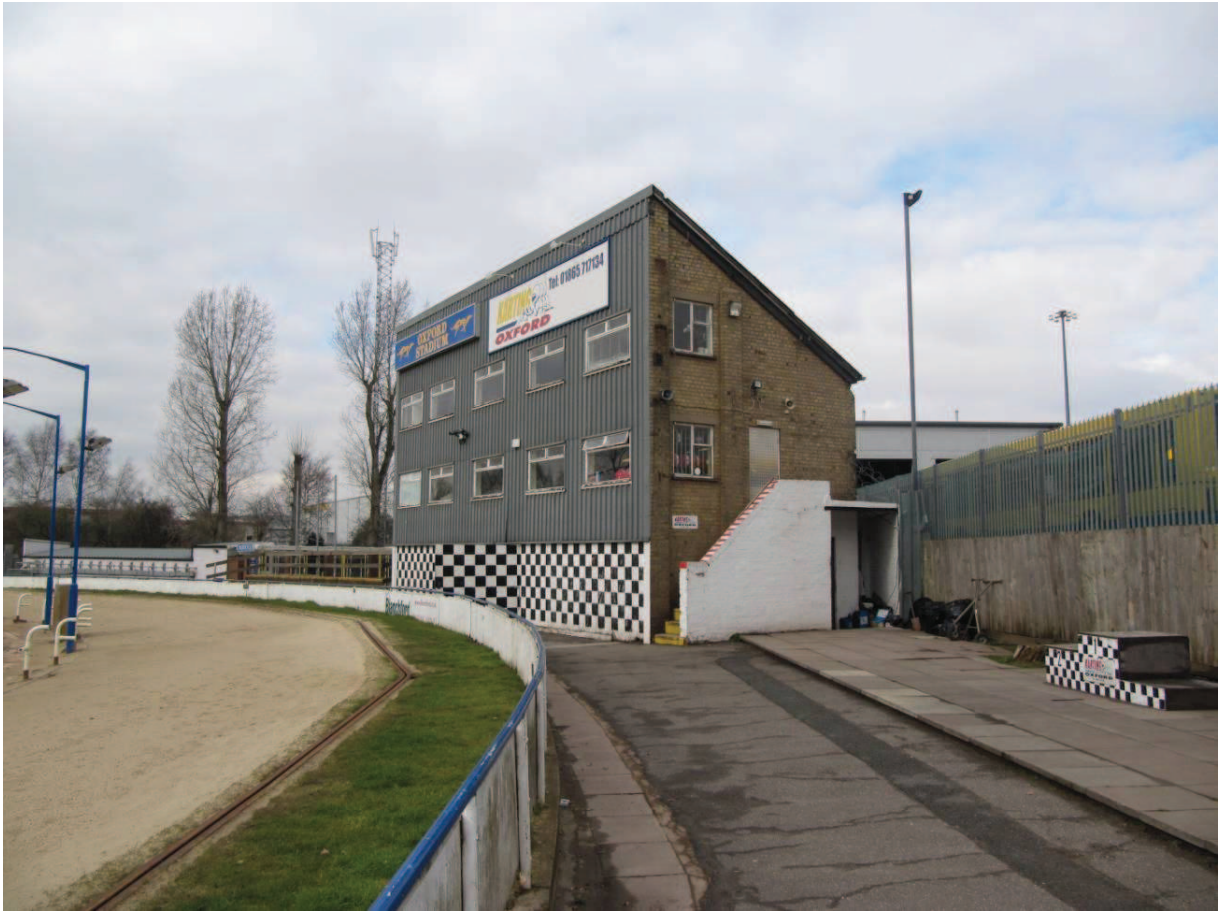
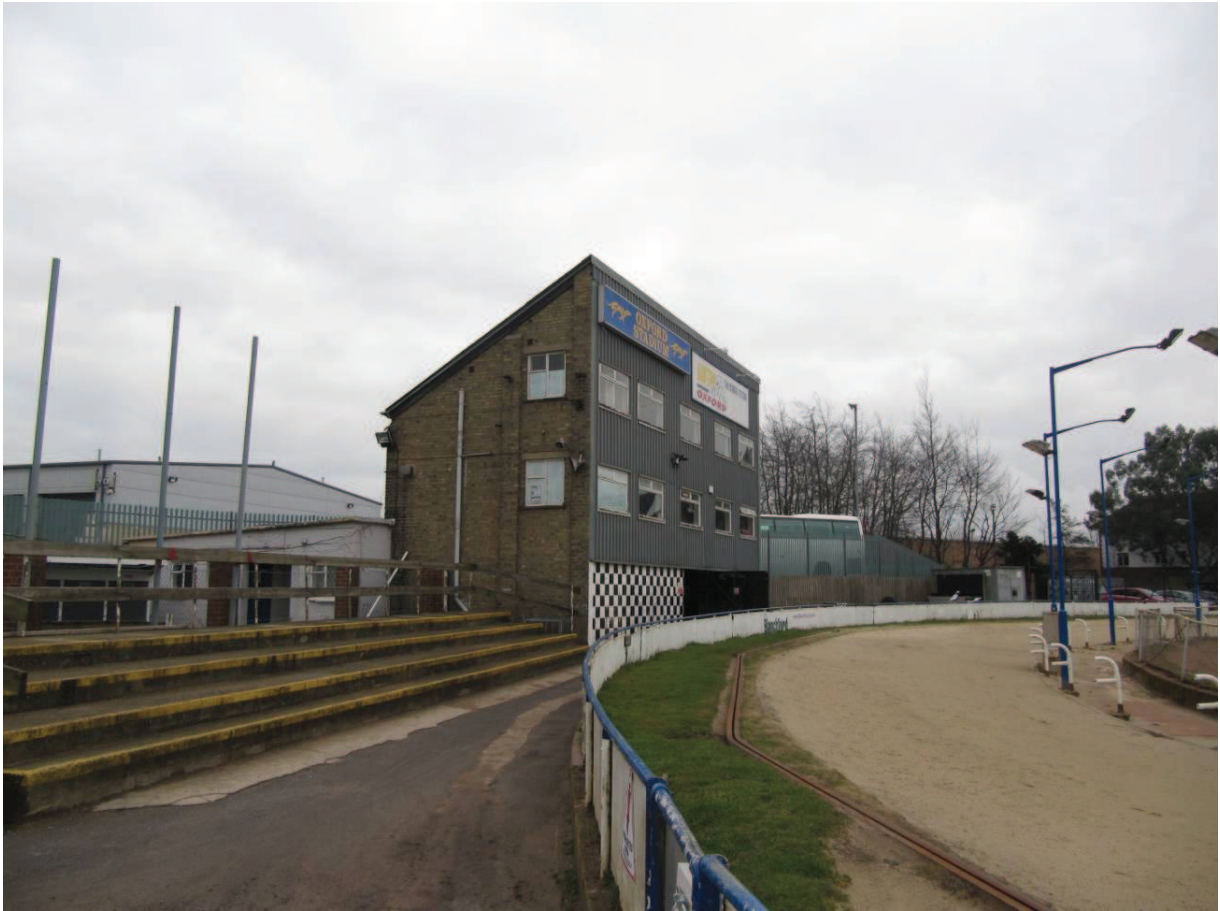
2.5 The Tote building is on the eastern side of the track. It is a 3-storey building with an external stair, mono-pitch roof and yellow stock bricks to the flank walls. A small concrete terrace is attached to the north side (**Photographs 7 and 8**).

Photograph 7 – Tote building

**Photograph 8 – Tote building**

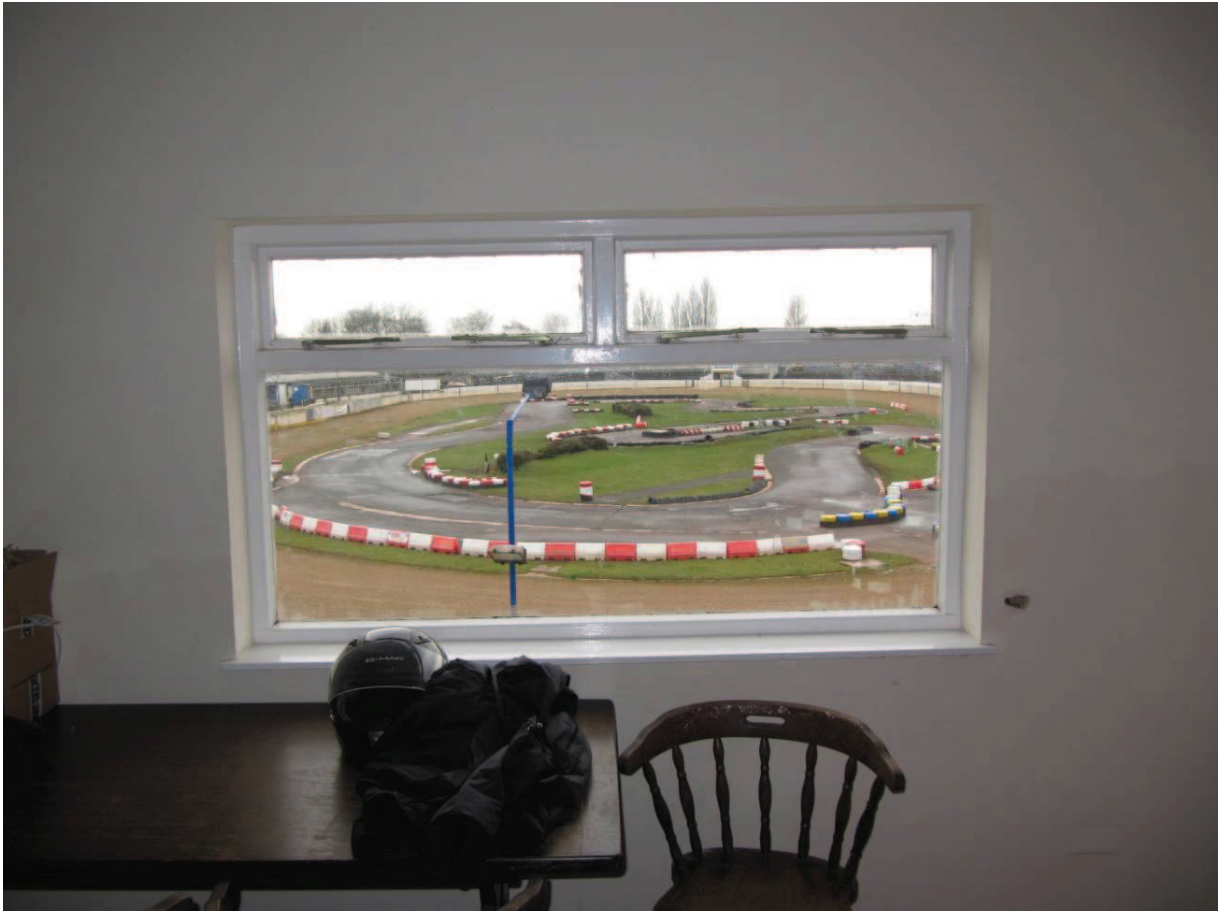
2.6 The front elevation of the building has been re-clad, signage has been added, and modern windows have been inserted (**Photograph 9**). Additionally, we understand that a former ground floor seating area has been removed. We were advised on site that a former Tote board is present behind the new cladding to the front elevation. However, we could not verify this. If it is present it is unclear what sort of condition the board will be in.

Photograph 9 – window to Tote building

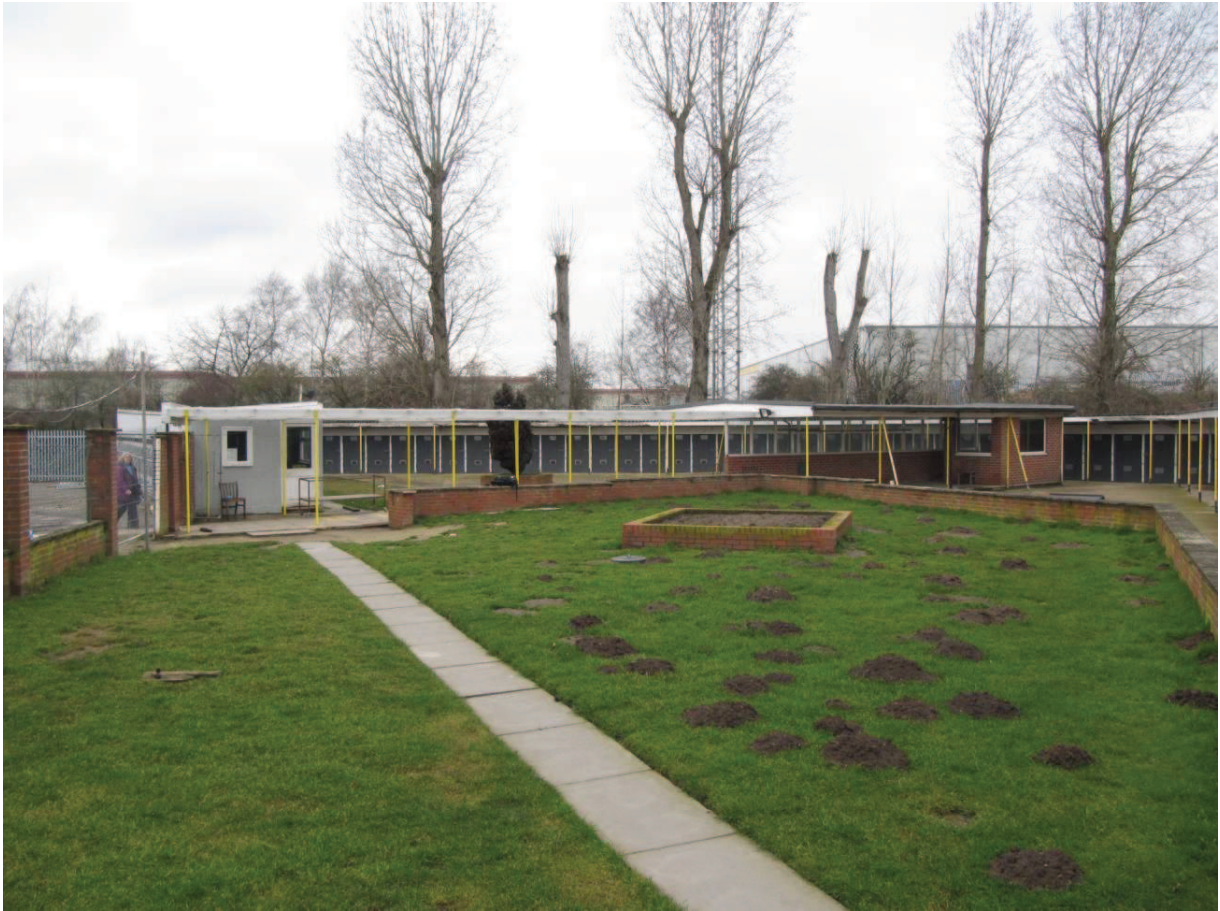
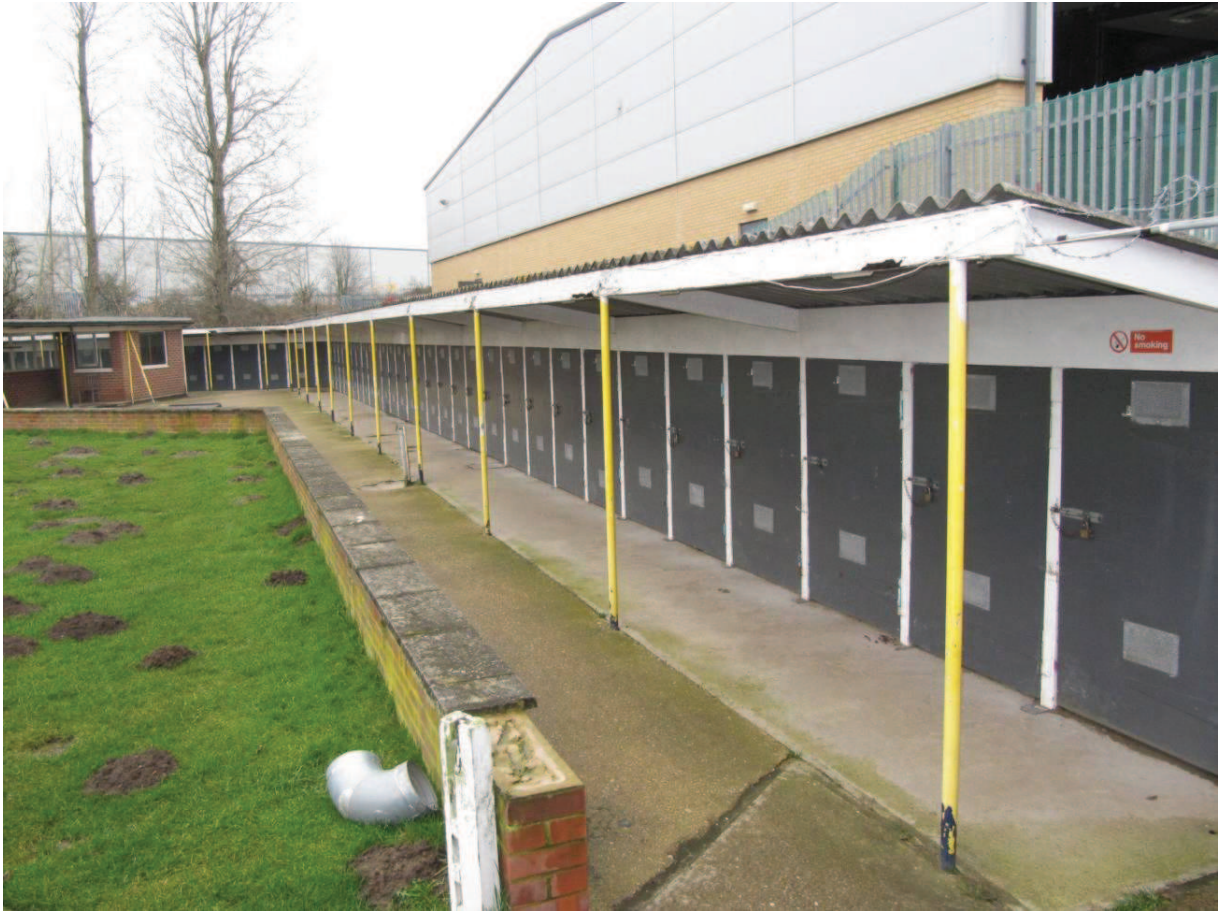
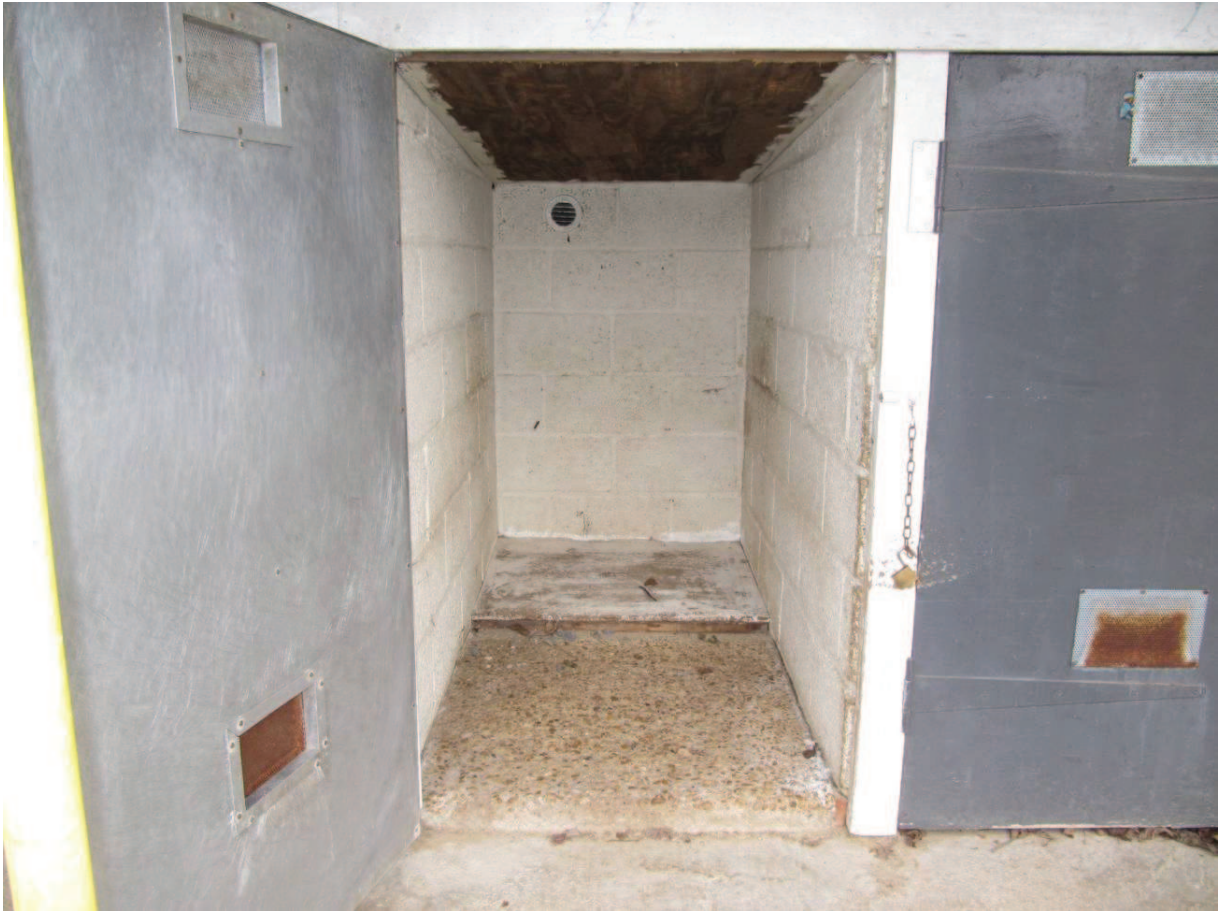
2.8 Further to the north of the Tote building (to the northeast of the track) are a range of kennels. These are of an expedient design, formed from blockwork, with asbestos roofs and timber doors. They are arranged around a grassed area with paving, and various walls and fences (**Photographs 10-12**).

**Photograph 10 – kennels**

**Photograph 11 - kennels**

**Photograph 12 - kennels**

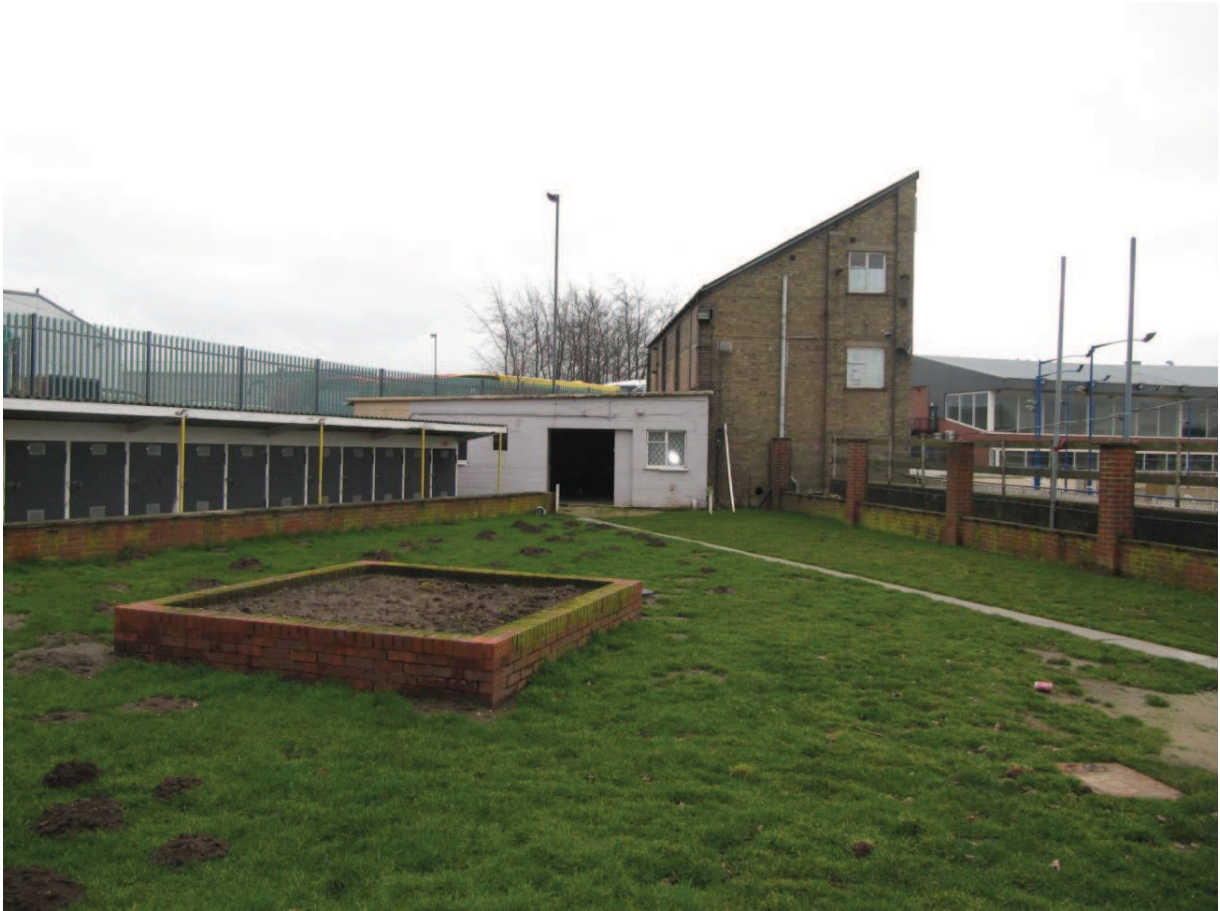
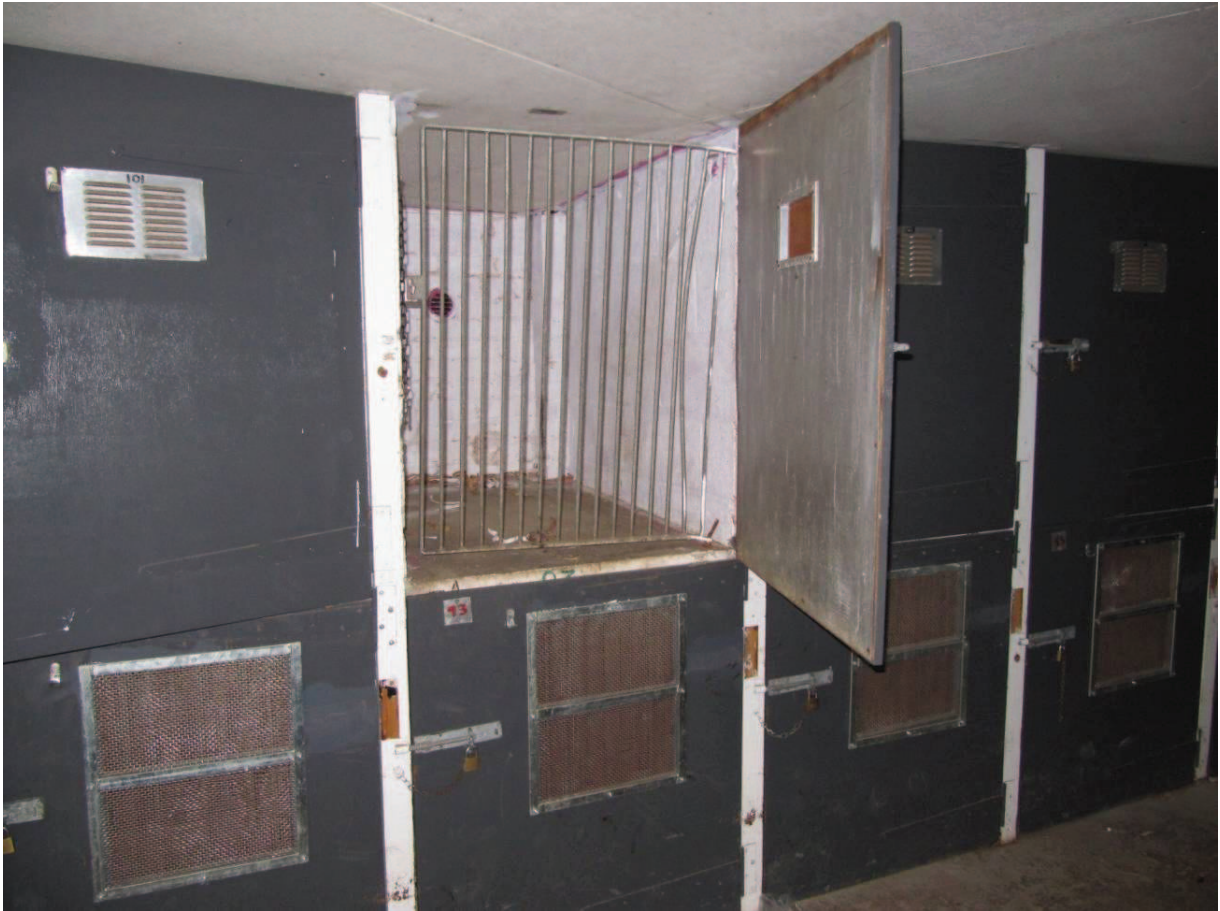
2.9 A separate structure constructed of painted brickwork contains further kennels, of a different, double-height, design (**Photographs 13 and 14**).

Photograph 13 – kennels

Photograph 14 – kennels
