**GALLIARD HOMES**

**OXFORD STADIUM  
SANDY LANE, COWLEY**

**HERITAGE ASSESSMENT**

**11 APRIL 2013**

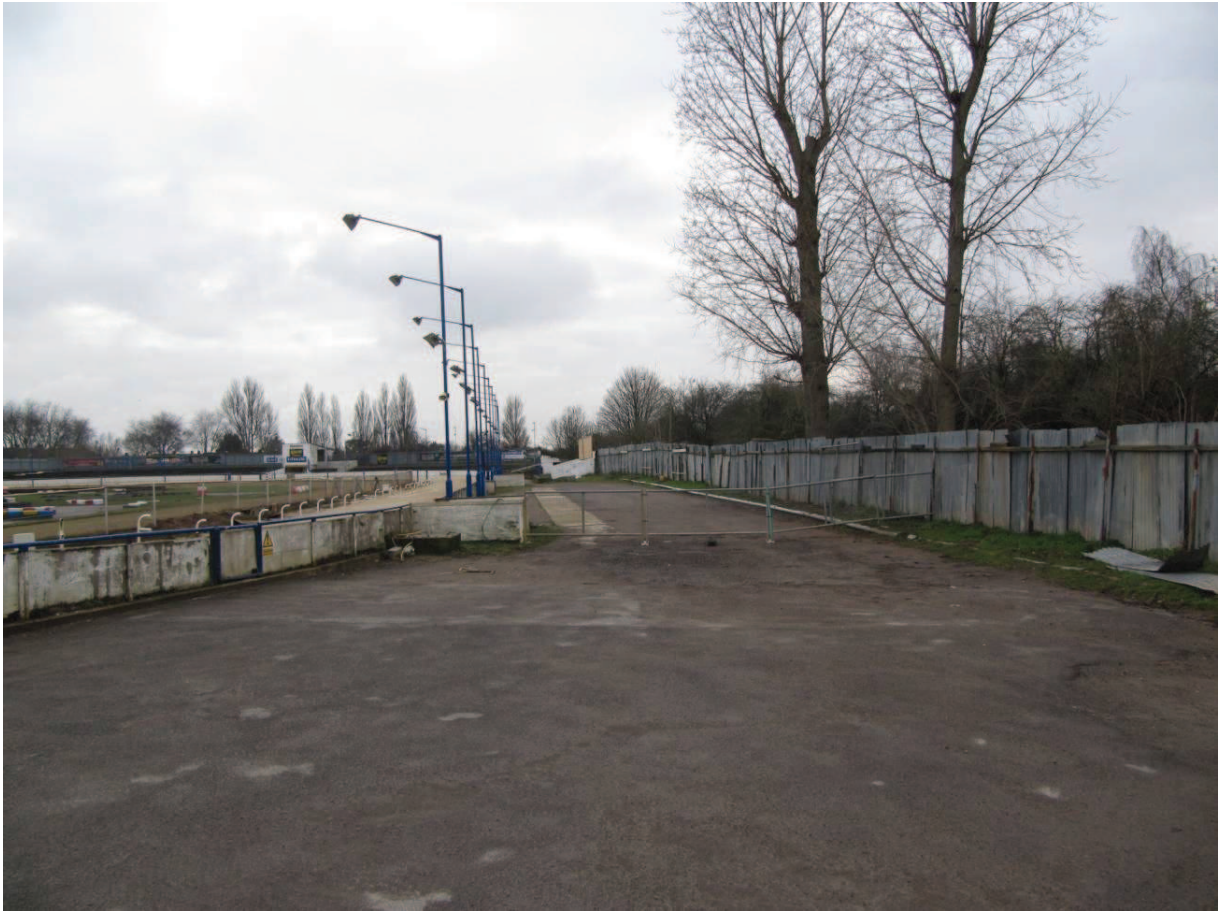
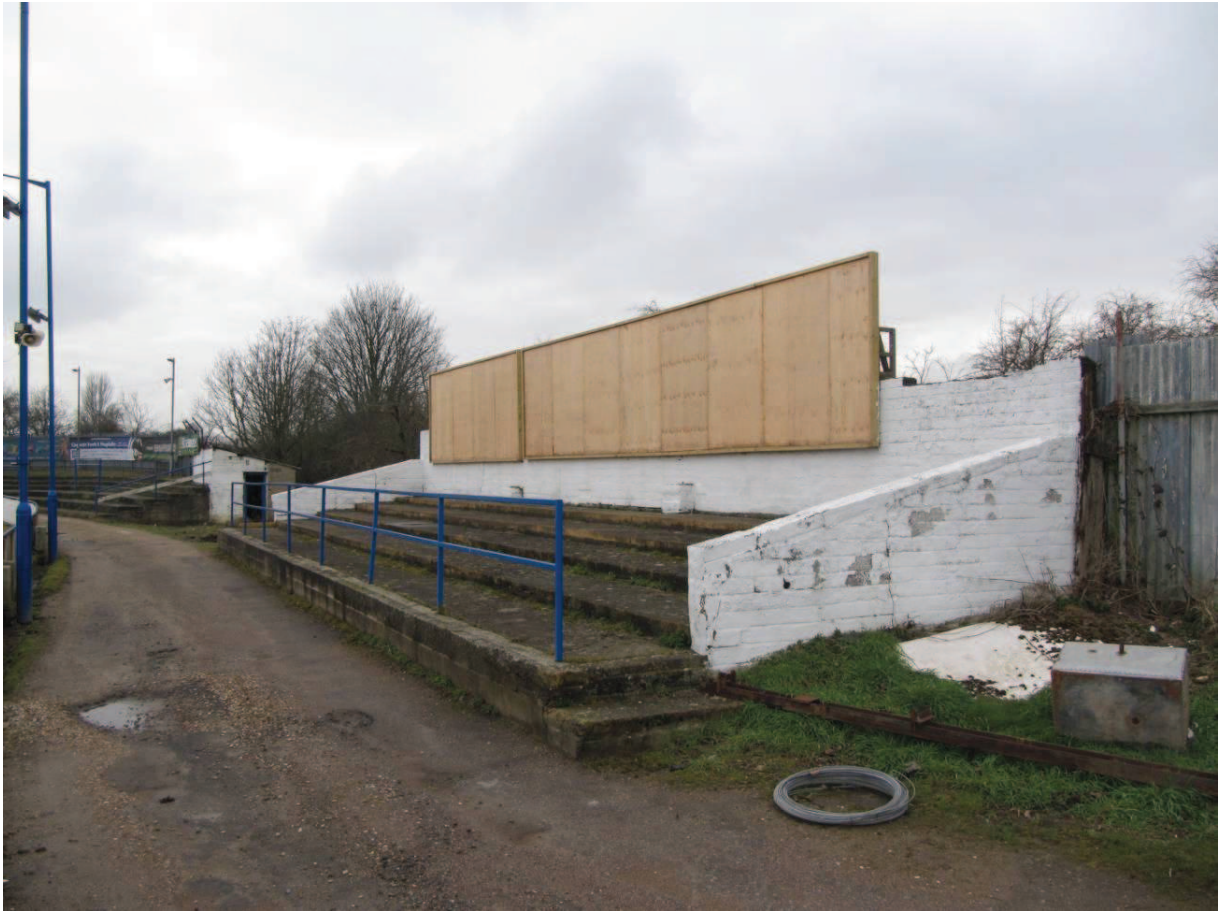
- 2.10 The north side of the track is largely devoid of structures (**Photograph 15**). A small concrete terrace with painted brick walls is present towards the western end of the track (**Photographs 16**).

**Photograph 15 – north side of stadium**

**Photograph 16 – terrace to north side of stadium**

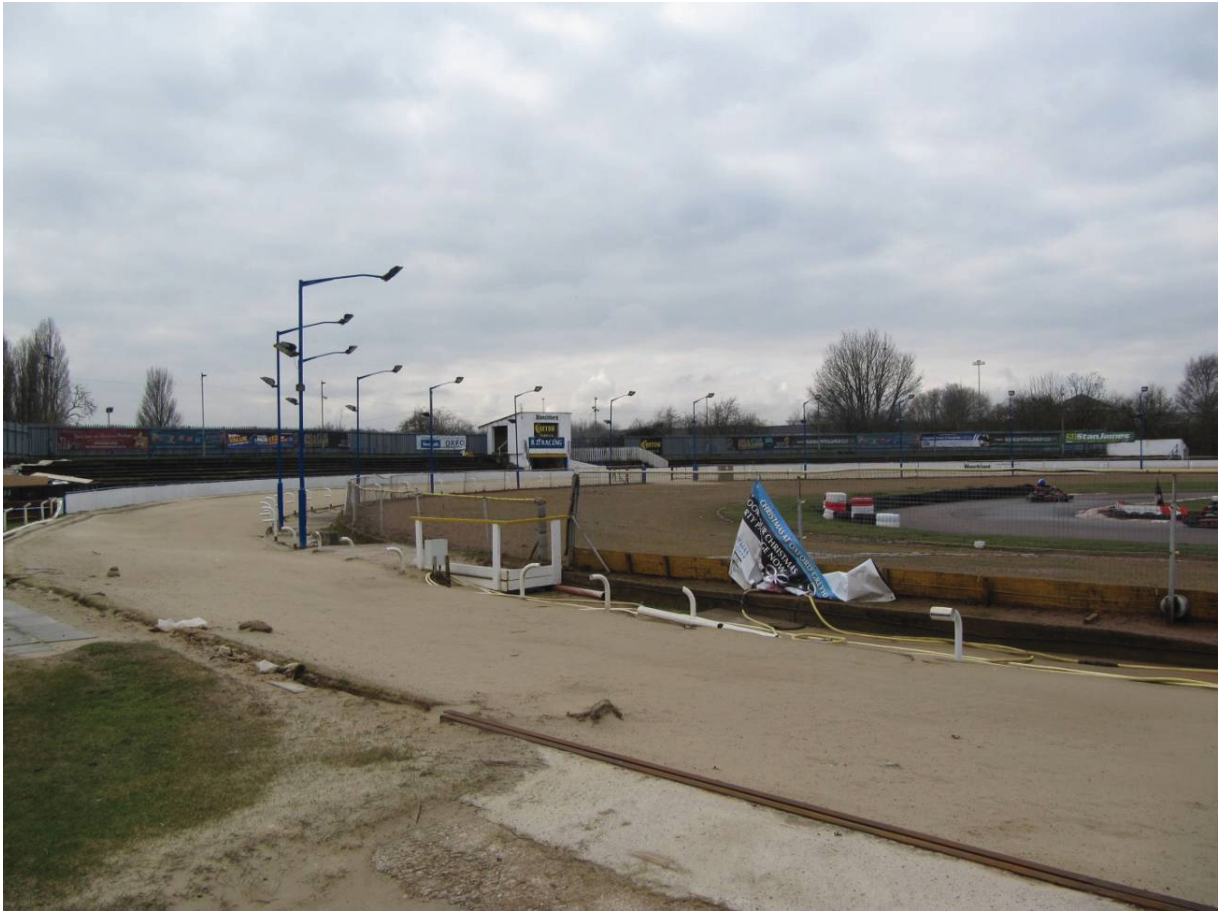
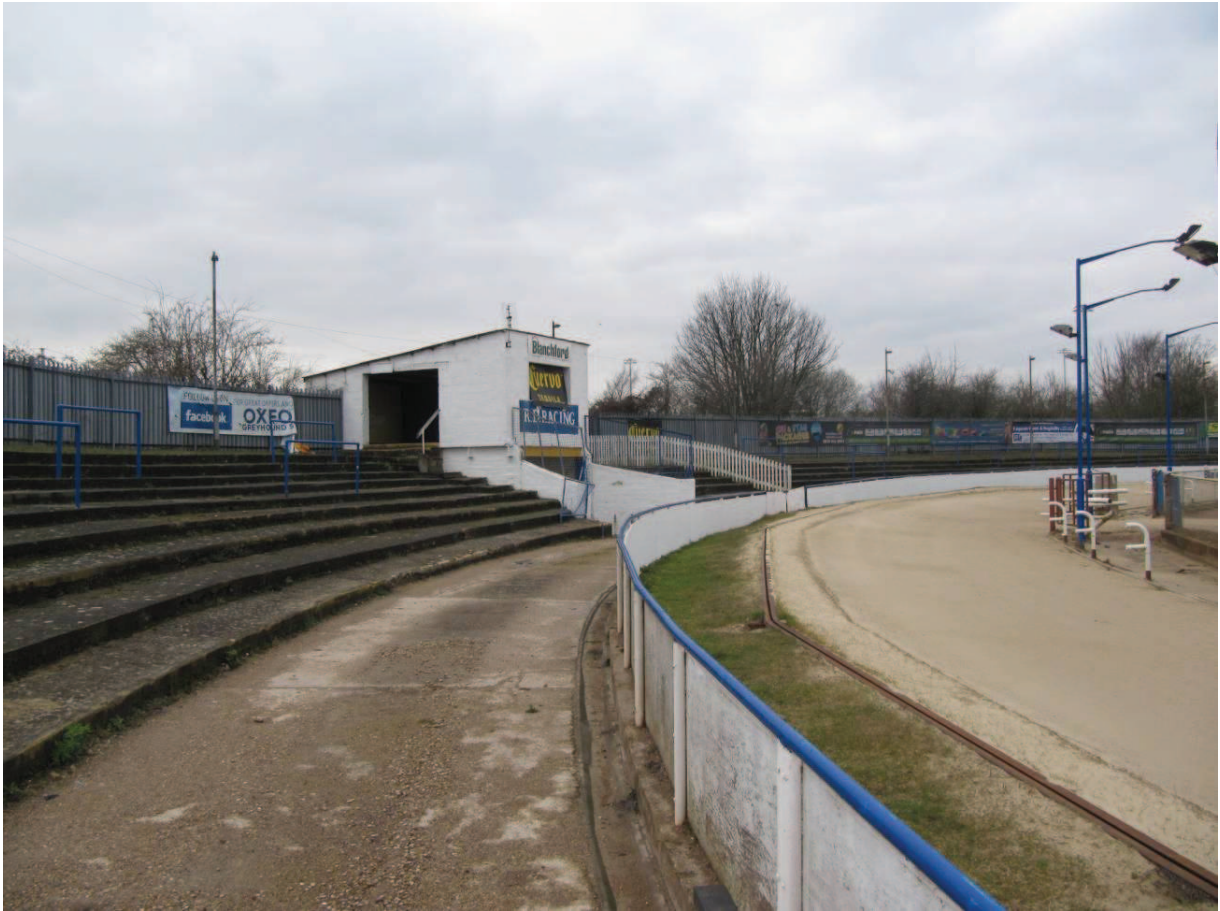
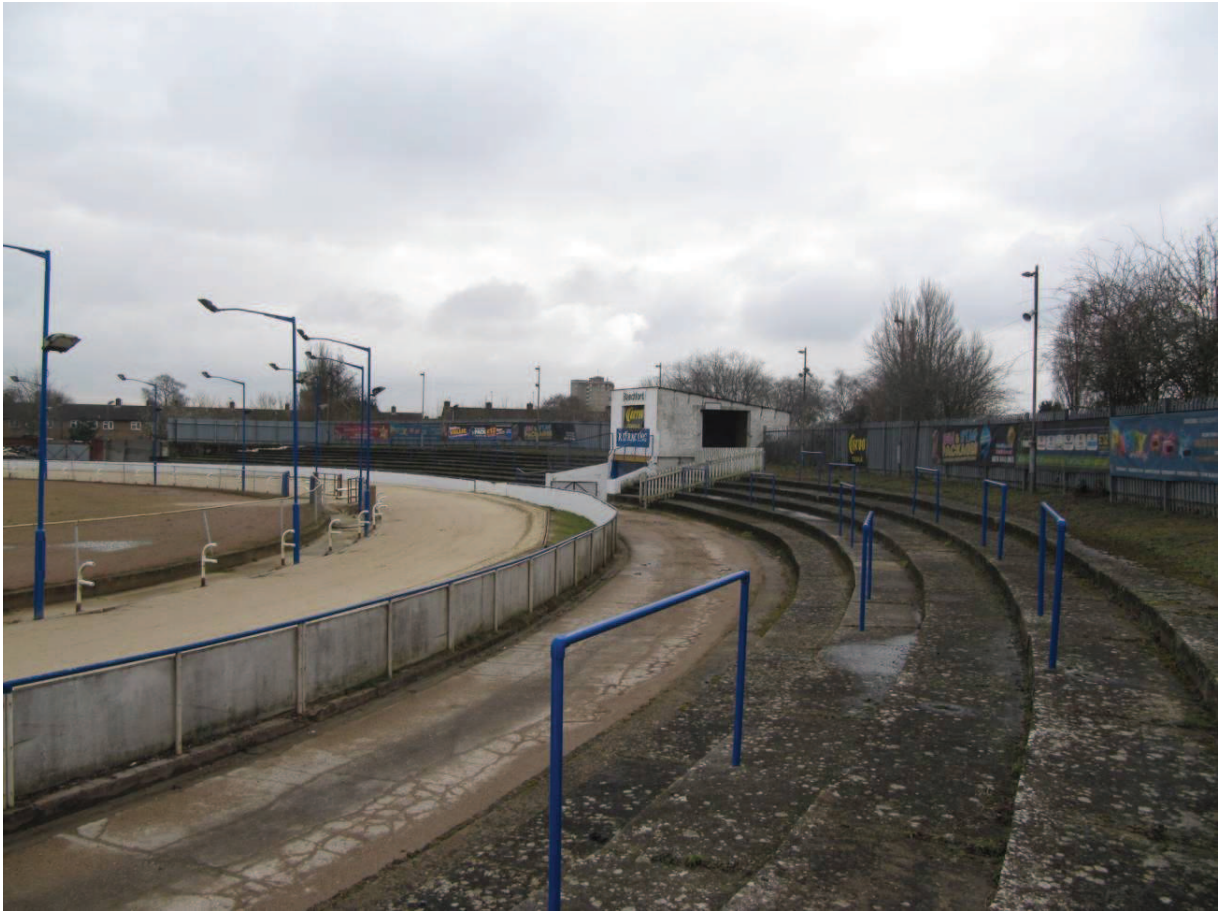
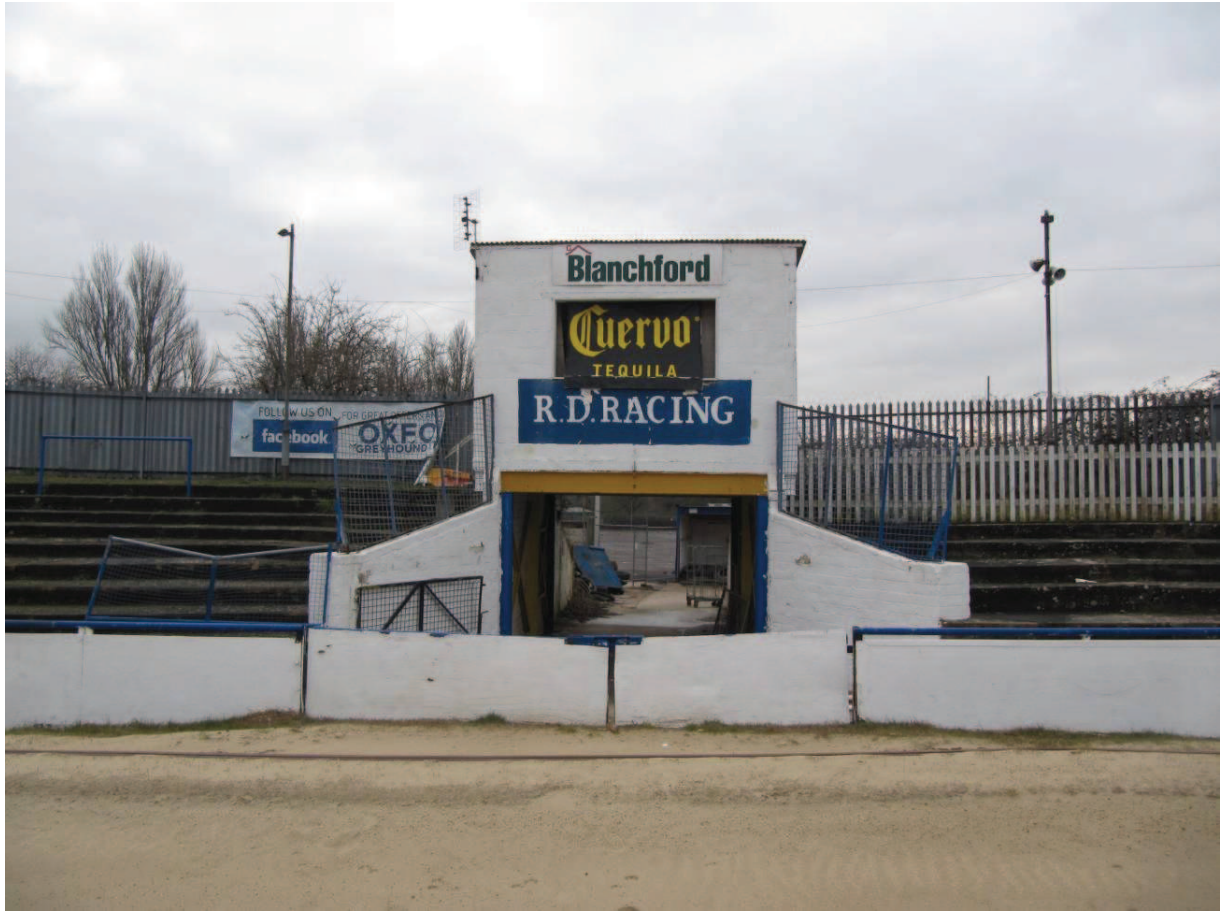
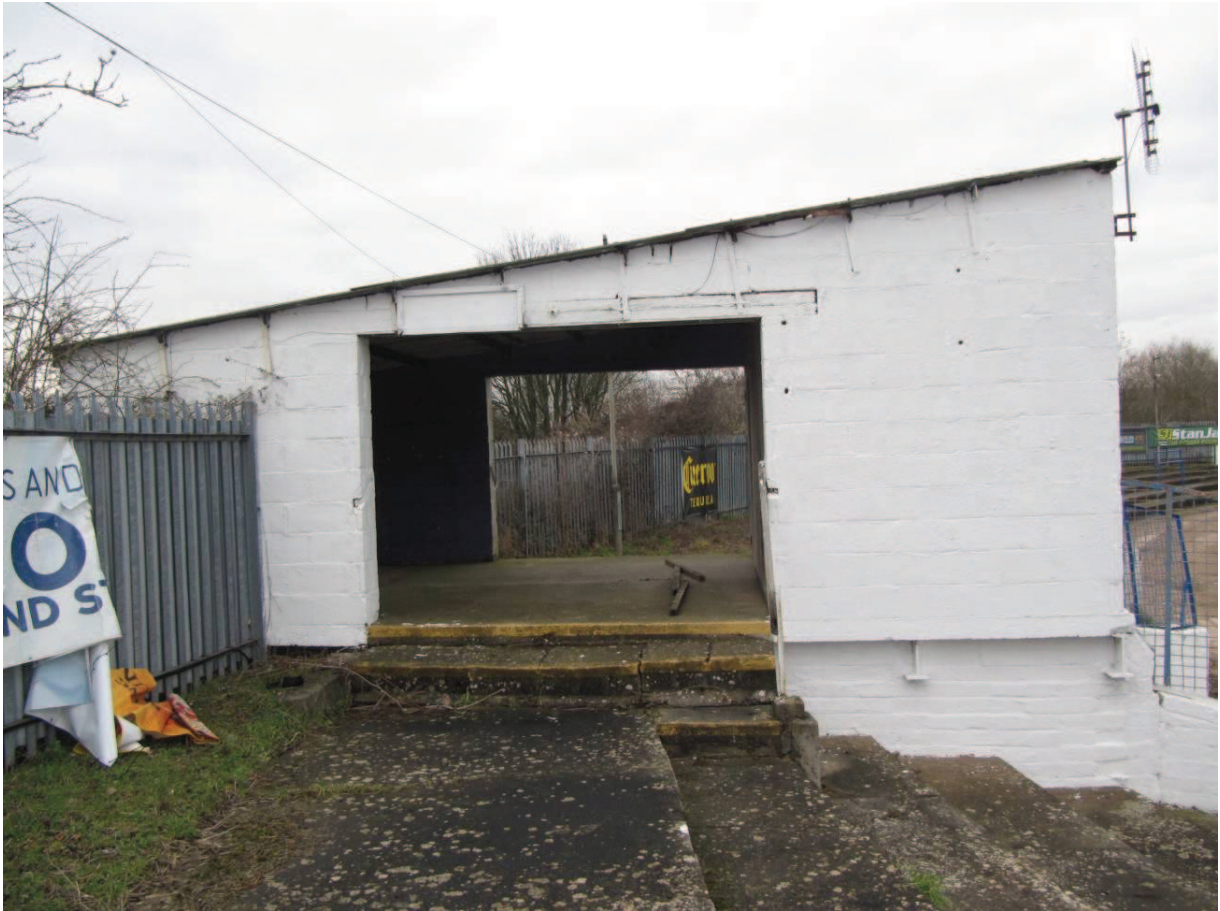
- 2.11 A curved terrace is present on the west side of the stadium, following the curve of the greyhound racing track. This is formed from concrete with associated timber and metal fencing (**Photographs 17-19**).
- 2.12 At the centre of the terrace is a painted brick and blockwork structure which is open at its sides (**Photographs 20-21**). This is potentially a former commentary position as the front elevation includes timber shutters allowing views towards the track.
- 2.13 Below this structure is an access from the track to a yard area to the rear of the western terraces. Painted steel structural elements are present to the side walls of the access (**Photographs 22-23**).

- 4.15 The western curving terrace either side of the entrance through to the former paddock, now a car park, is of simple concrete and block construction. The poor quality of concrete is showing its age and is crumbling and broken. The block constructed entrance to the former paddock has no aesthetic value. The terrace is typical of the period. The terrace has no aesthetic value.
- 4.16 The single storey buildings west of the terrace appear to have been used by the speedway teams in latter years. The single storey buildings have no aesthetic value and the paddock was converted to a car park many years ago.

Photograph 17 – terraces to west side of stadium

Photograph 18 – terraces to west side of stadium

**Photograph 19 – terraces to west side of stadium**

Photograph 20 – terraces to west side of stadium

Photograph 21 – terraces to west side of stadium

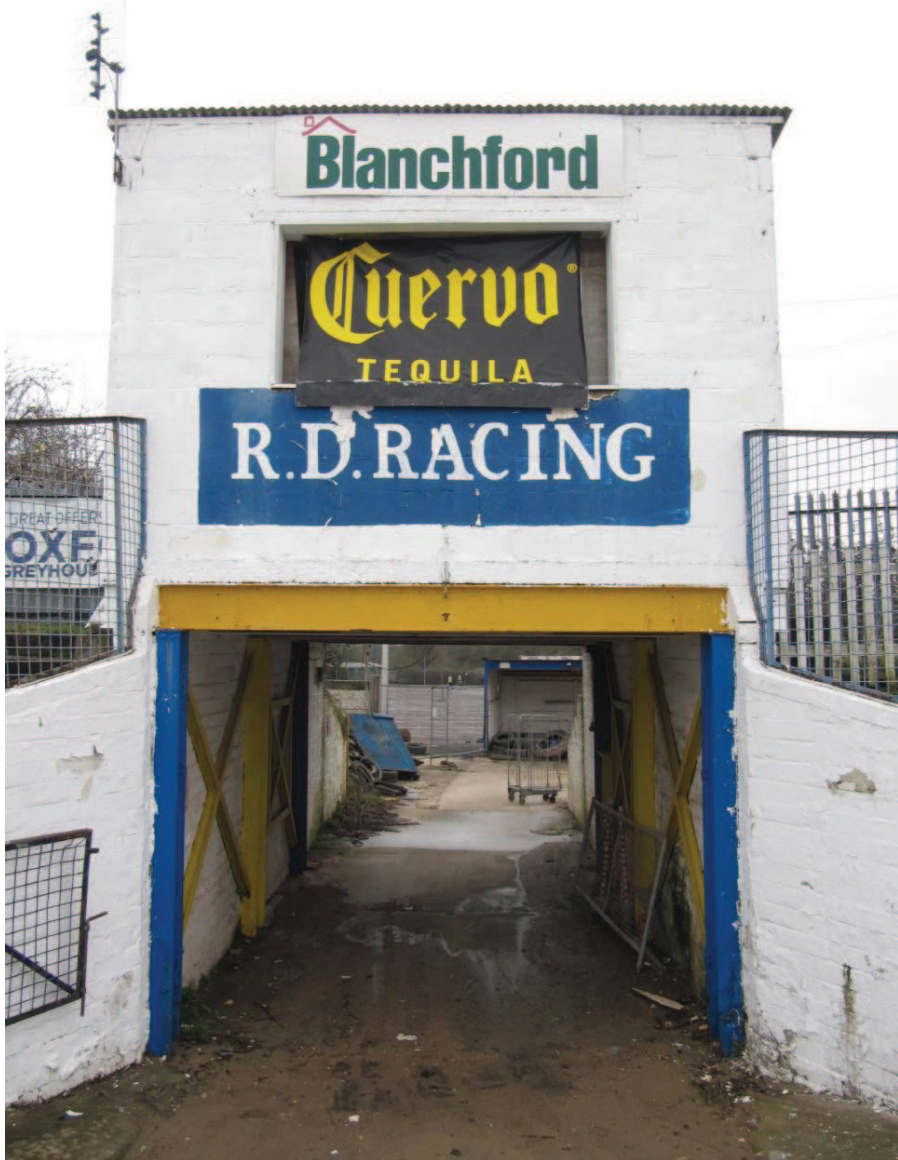
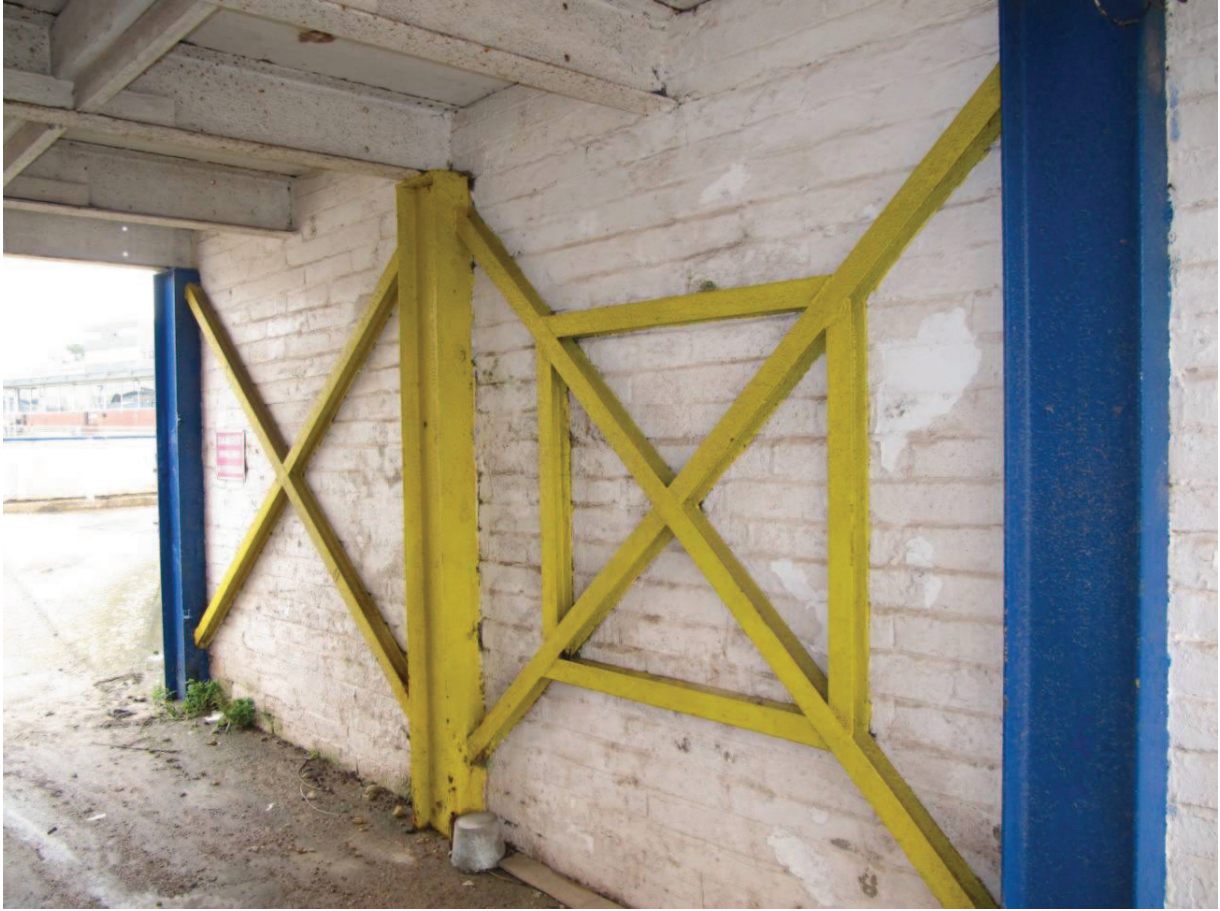
Photograph 22 – entrance to yard area to west side of stadium

**Photograph 23 – entrance to yard area to west side of stadium**

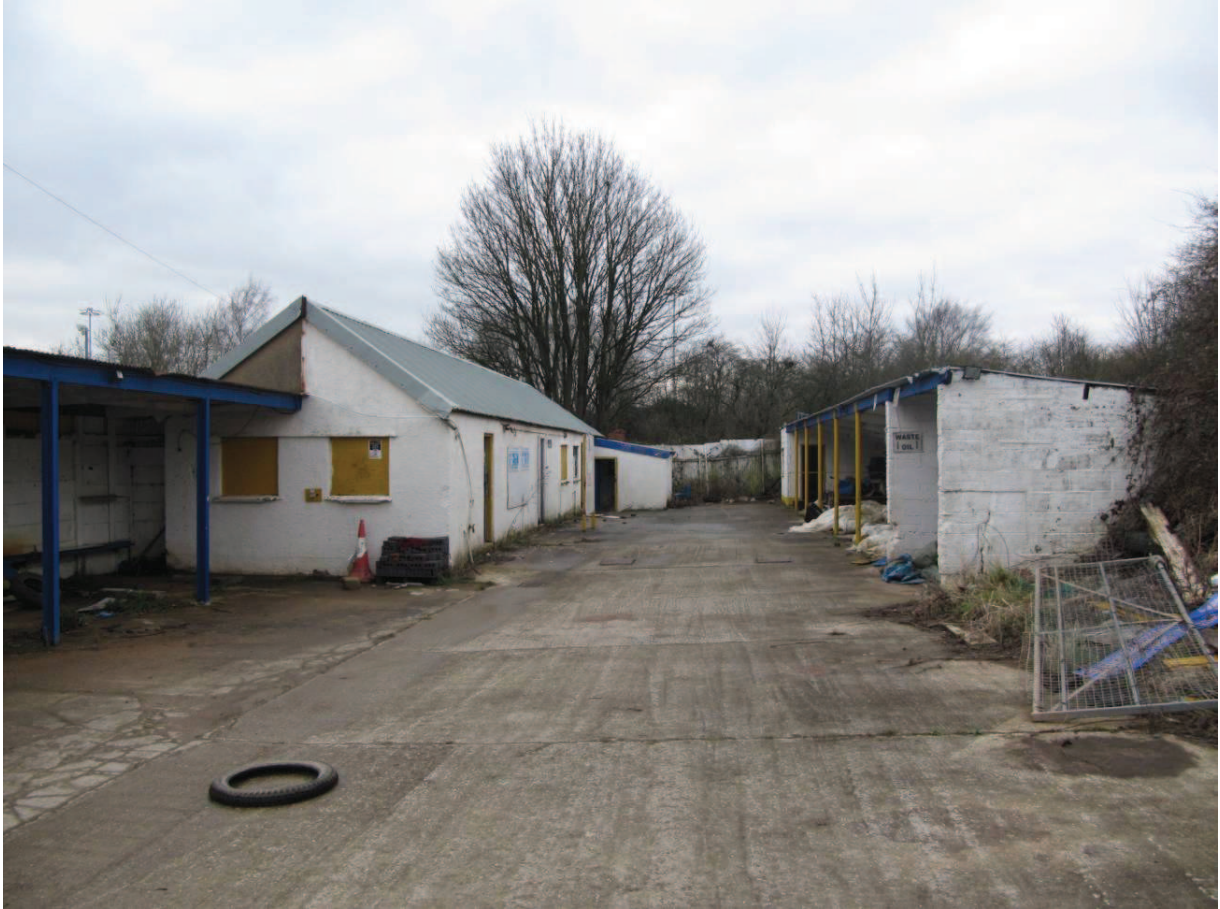
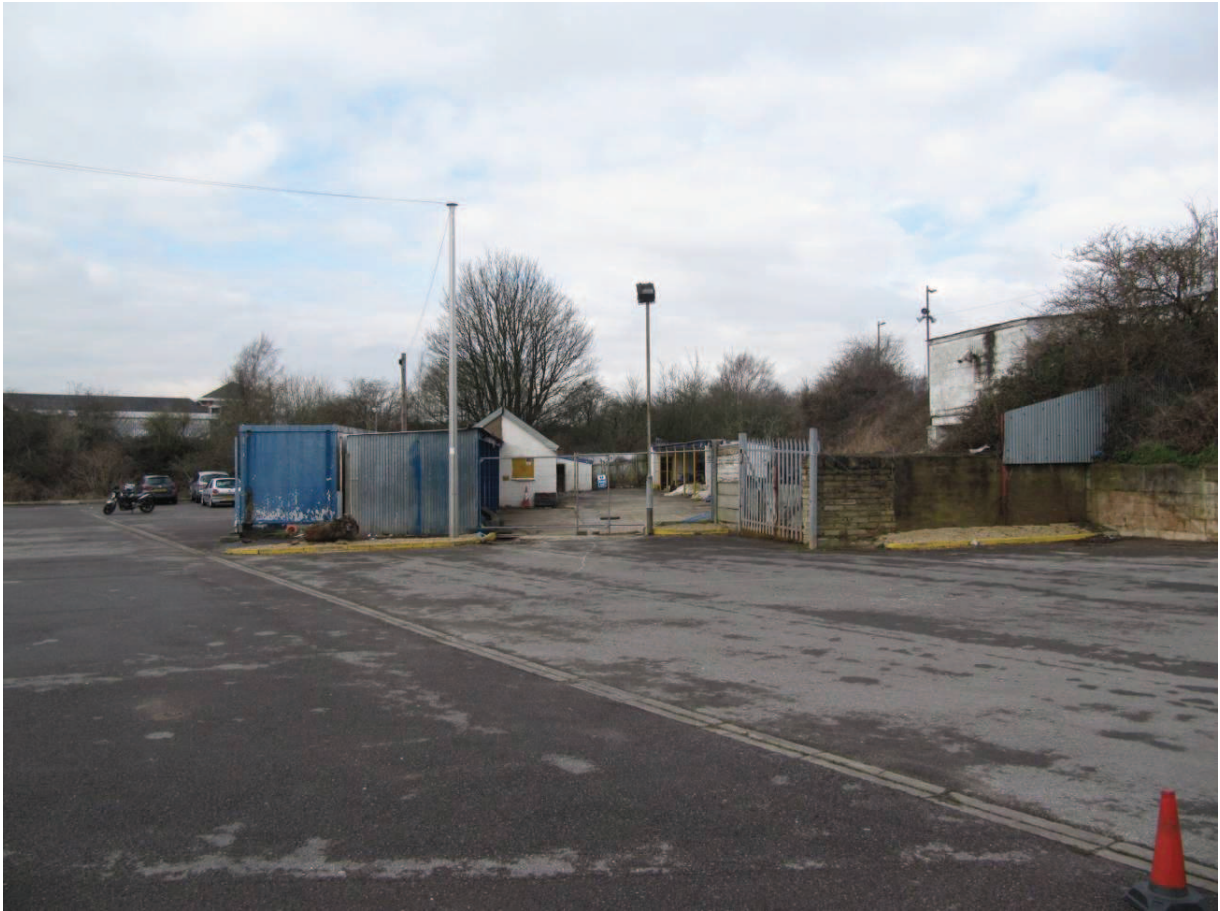
- 2.14 The yard areas contain a range of painted ancillary buildings which appear to have formerly been used as changing rooms and a pit area associated with Speedway events at Oxford Stadium (**Photograph 24**).
- 2.15 Beyond the yard area is a large surface car park (**Photographs 25**).

Photograph 24 - yard area to west side of stadium

**Photograph 25 – car park and yard area to west side of stadium**

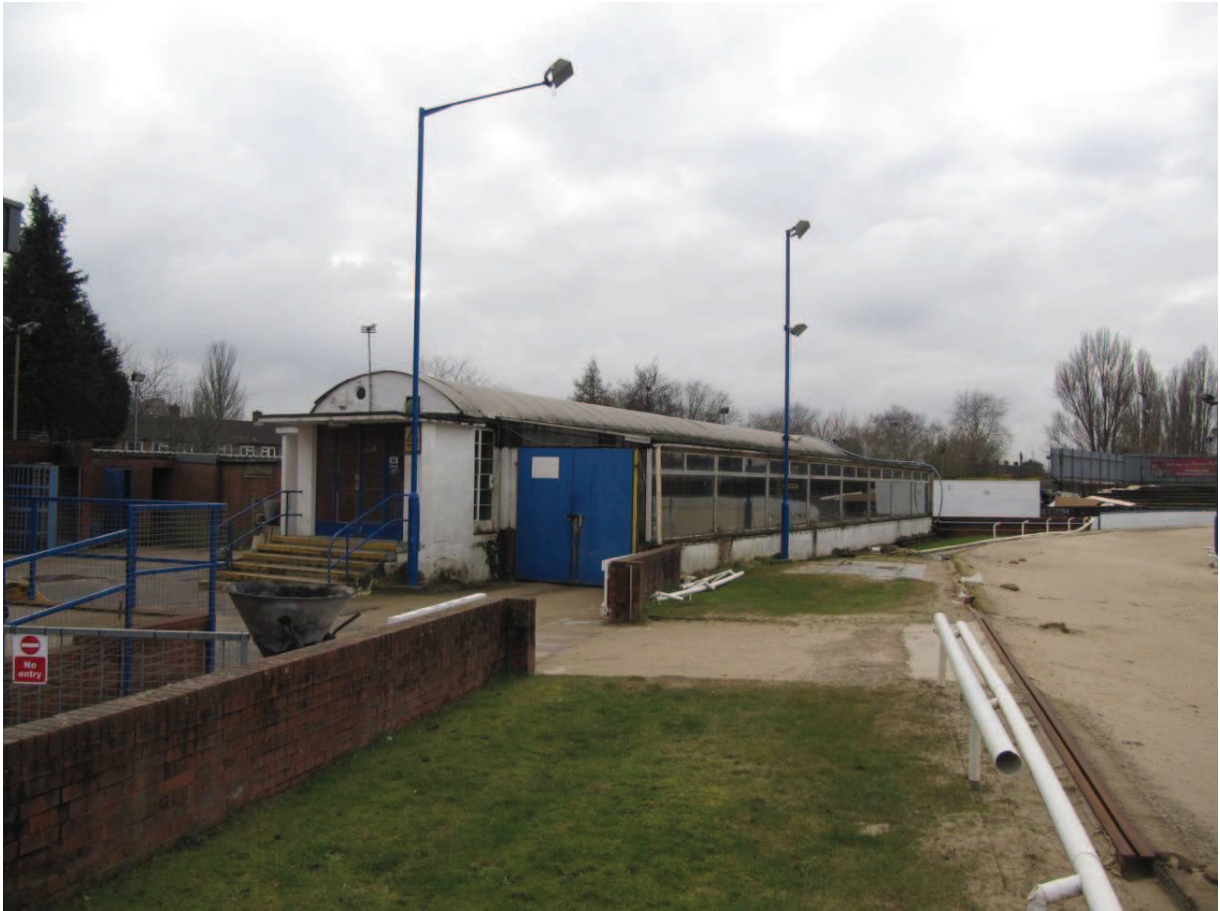
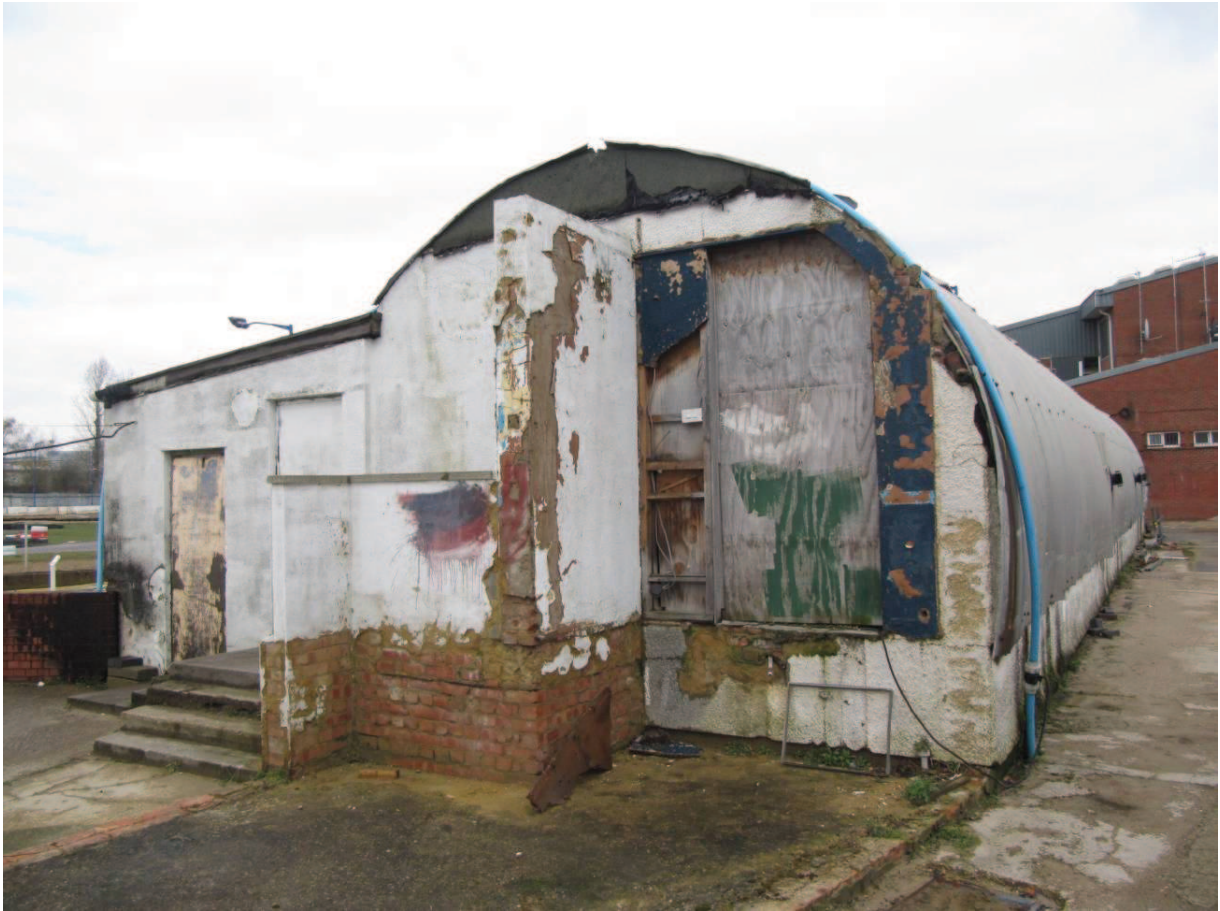
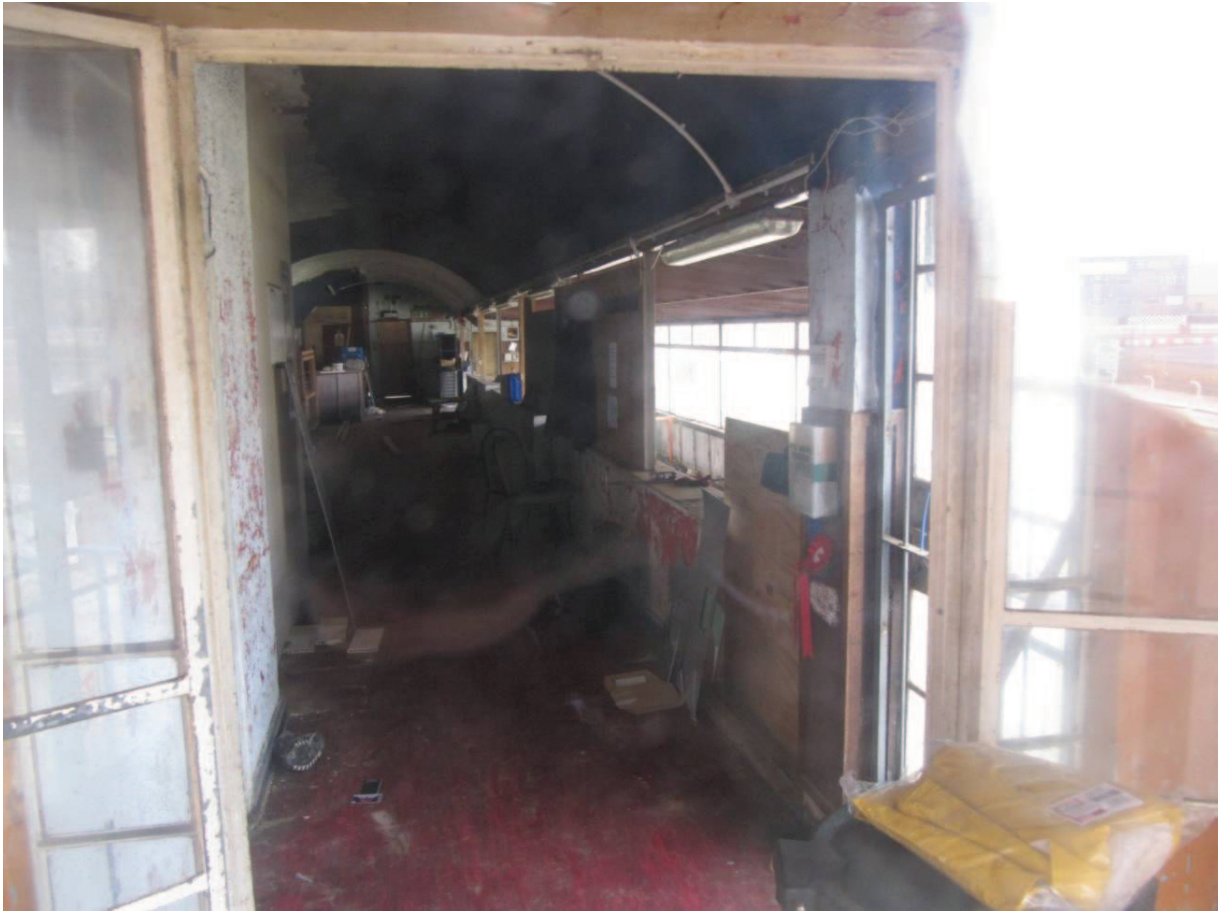
- 2.16 This has a curved roof form and has a glazed lean-to extension to the front (**Photographs 25-27**). The building was initially used as the Director's Bar (see Section 3.0 below) but we were advised on site that the last use was as a storage garage for equipment used to service the greyhound racing track.
- 2.17 Although we were unable to access the interior of this building it appears to be largely open and devoid of internal features (**Photograph 28**).

- 4.17 The former Director's Bar resembles a small elongated Nissen hut. It was extended to the front, which doubled the size of the structure. The structure is glazed to the front to allow trackside views. The rear part is of concrete blocks with a corrugated iron roof. It has been much altered internally. The poor quality of construction and materials used are evidenced by its poor condition. It is of no aesthetic value.

Photograph 26 – Nissen Hut (former Director's Bar)

Photograph 27 – Nissen Hut (former Director's Bar)

**Photograph 28 – Nissen Hut (former Director's Bar)**

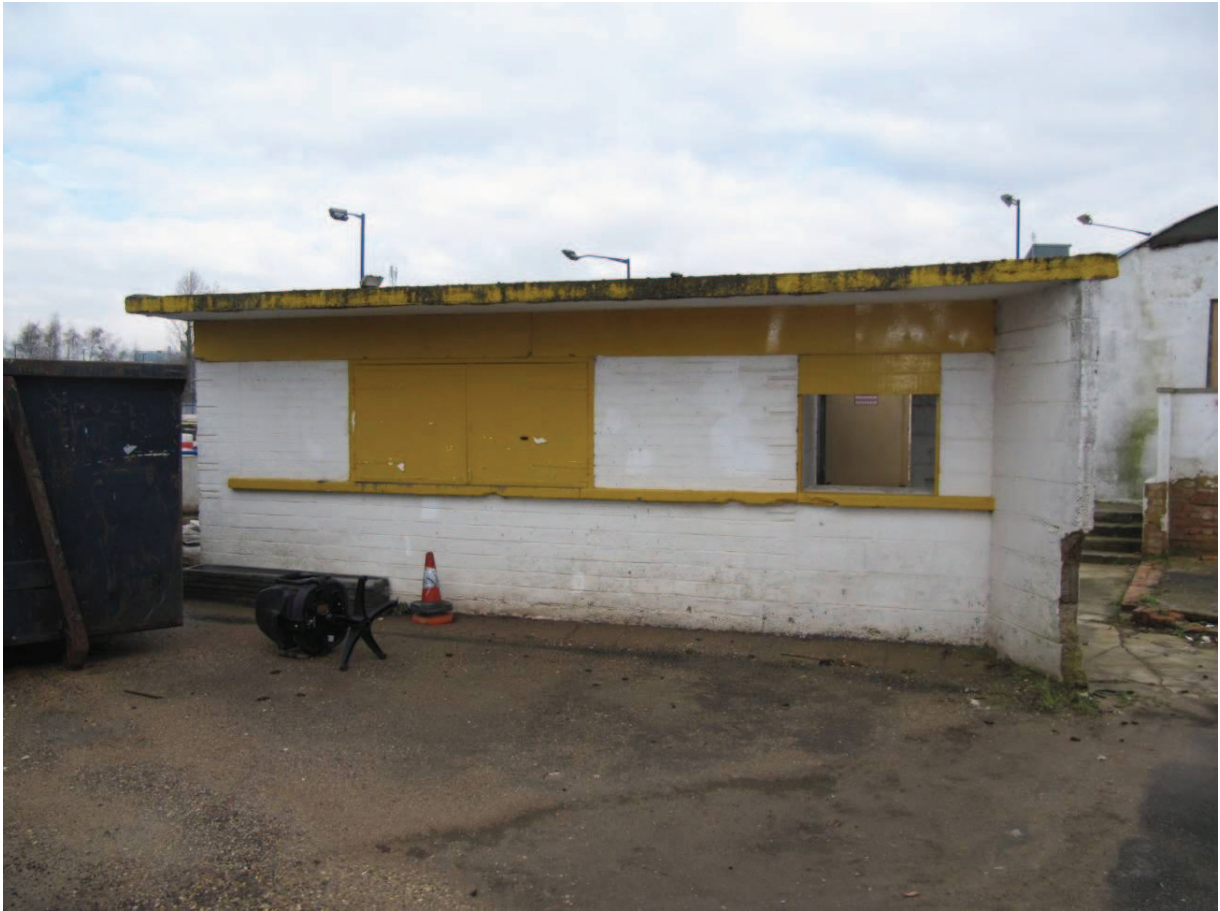
- 2.18 A flat-roofed painted brick kiosk is present adjacent to the Nissen Hut (**Photograph 29**). Its main elevation includes serving hatches and it is assumed that the building was used to provide refreshments to spectators.

**Photograph 29 – kiosk next to Nissen Hut (former Director's Bar)**
