## Oxford City Planning Committee Presentation

21/02431/FUL & 21/02432/LBC

Meadow Larkins, Larkins Lane

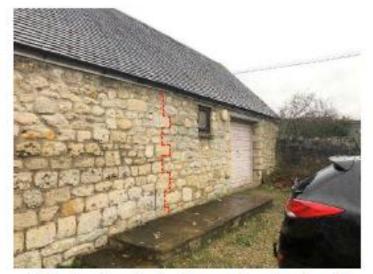
a. 1970s alterations clearly visible around creating of opening for garage door and removal of original gable and break in building line

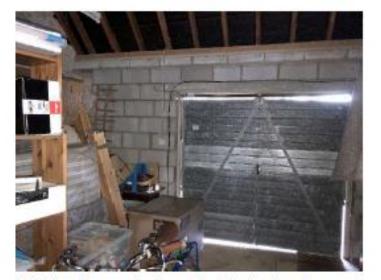
b. Interior of garage showing modern blockwork and new roof

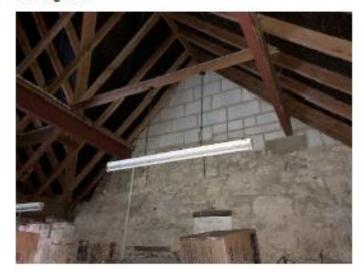
c. Interior of garage showing modern blockwork alterations to create the gable of the stables and new roof structure

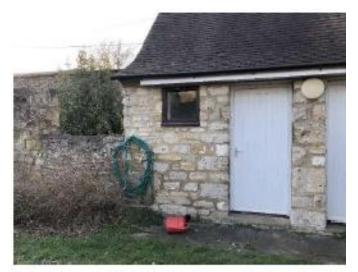
d. Exterior of utility showing example of the modern alterations and poor quality repointing to the stonework evident throughout the building.
